Design Improvements - Merc 18 and Merc 25

CIRCULATE TO:
SERVICE MANAGER
PARTS MANAGER
MECHANICS

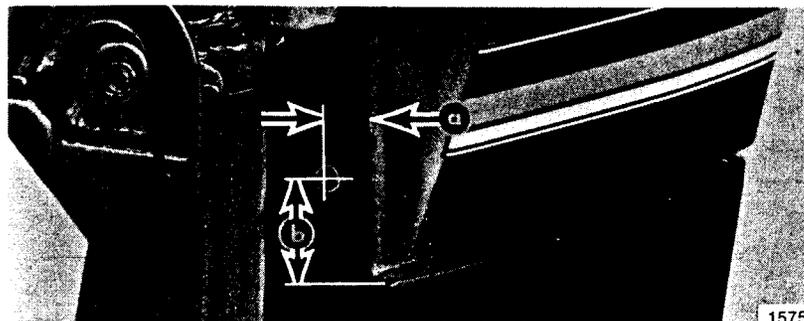
Figure 1. Vent Hole in Drive Shaft Housing

This vent hole serves to relieve a vacuum in the drive shaft cavity of the housing, thus maintaining a lower water level in this cavity and preventing water from rising to powerhead level.

NOTE: This vent hole (located where shown) does not, in any way, affect cooling system efficiency and/or engine performance. There WILL NOT be any discharge (exhaust, sound or water) from this hole because engine exhaust is channeled thru another, separate cavity.

Drill a $\frac{3}{8}$ " (9.52 mm) diameter vent hole thru one wall of the drive shaft housing on the PORT side (steering handle side) of engine, at the location shown in Figure 1.

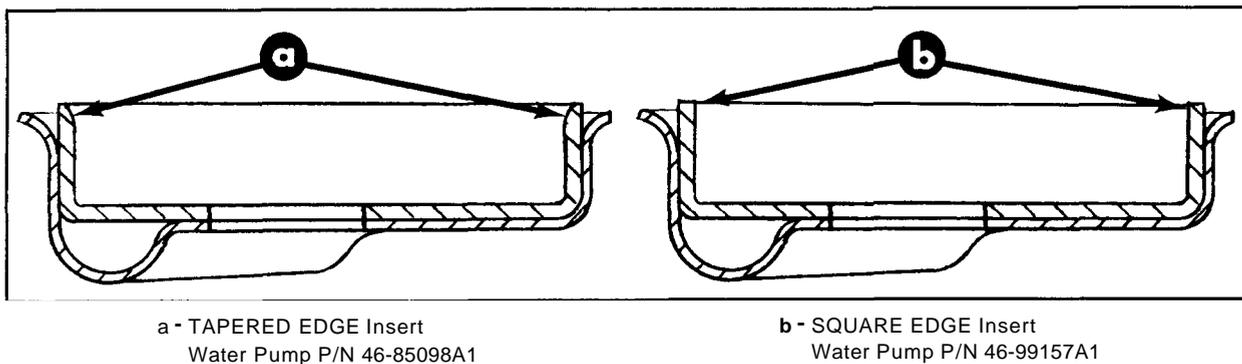
Figure 2. Water Pump Assemblies

Whenever the gear housing assembly is removed from the motor for service, inspect the water pump assembly to determine the type of insert used in the pump. (Figure 2)

- 1) If the water pump assembly is equipped with a TAPERED EDGE insert, replace the water pump assembly with a new water pump assembly P/N 46-99157A1 (with a SQUARE EDGE insert).

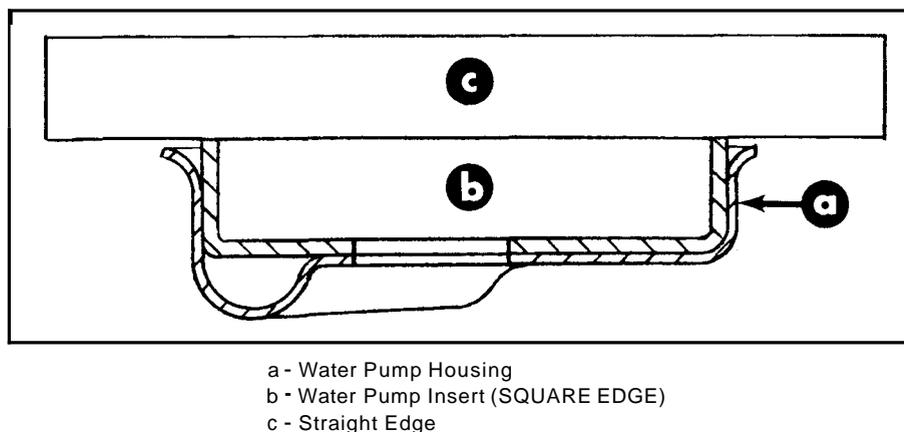
Figure 3. Checking Position of Water Pump Insert

- 2) Water pump assemblies with a SQUARE EDGE insert also should be checked with a straight edge (Figure 3) to make certain that the insert is not cocked in the housing.

The insert must protrude from the housing (MUST BE ABOVE the housing) all the way around the housing. If the straight edge contacts the water pump housing at any point, replace the water pump assembly with a new P/N 46-99157A1.
