NUMBER: 83-13

POWER TRIM PUMP TO POWER TRIM SOLENOID WIRING HARNESS ROUTING 1984 MODELS 75-90-115

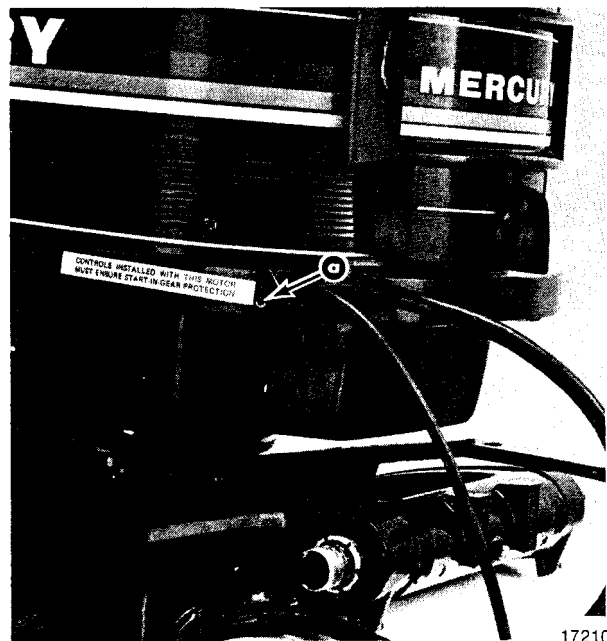
Figure 1. Old Harness Routing

A potential steering interference exists with the routing of the Power Trim pump to Power Trim solenoid on 1984 model 75-90-115 outboards. The problem can occur as the wiring harness makes its way along the right transom bracket. With the generous loop forward, prior to entering the powerhead, the harness can catch under the steering arm when the outboard is tilted full up and then let down again. This would restrict the amount of steering travel.

a - 5/32" Hole

1. Drill a 5/32" hole approximately 3/4" past the "Start in Gear" blue decal. (Figure 1)
2. Place a harness clip, part number 54-22875, on the harness and route the harness as shown in Figure 2.
3. Secure the harness and clip to the bottom cowl with washer, part number 69205 and self tapping screw, part number 10-69079.

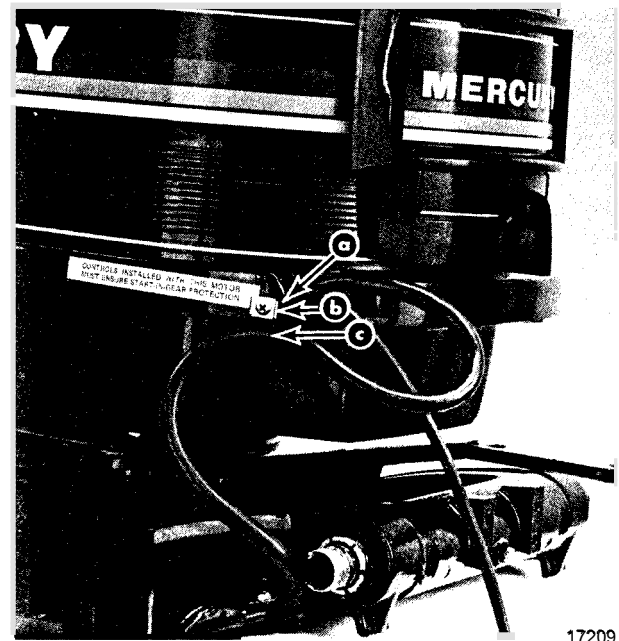
Figure 2. New Harness Routing

a - Washer

b - Screw

c - Harness Clip

All 1984 model 75-90-115 outboards that do not have the Power Trim pump to Power Trim solenoid harness routed, as shown in Figure 2, must be reworked as follows:

Rework all 1984 model 75-90-115 outboards as shown in Figure 2. .5 hour will be allowed for each rework. Send warranty claims to your Distribution Center.
