- A. Shorting in Phase-Maker Ignition System - 1 and 2-Cyl. 1971-72 Models
- B. "Troll Set" Knob Change - 1 and 2-cyl. 1972 Models
- C. Shift Cable Installation - Merc 1400 Model

- D. Chaffii of Ignition Module Leads - 1972 Merc 200
- E. Lubriplate 2C GL (50:1) Not Recommended
- F. Fuel Pump Diaphragm Kit Installation

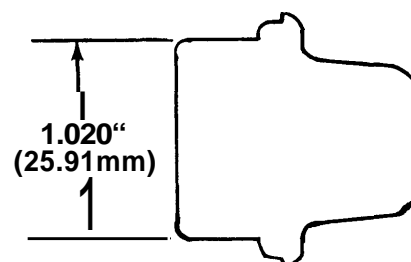
Figure 1. Knob Diameter

Should the "Troll Set" knob on 1972 Merc 200-110-75-40 models become loose or shake off, check the diameter of the knob, as shown in Figure 1. If the diameter is not as shown, replace the knob with Part No. A-62251.

A-62251 Throttle Handle Cap \$.55 U.S. List

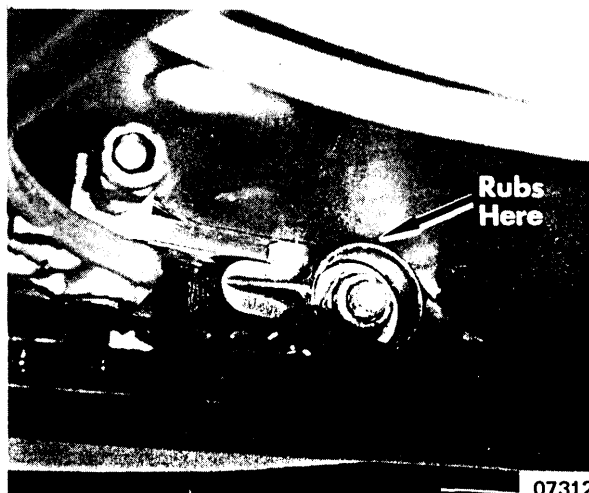
Figure 2. Control Cable Latch

If the control cable latch (A-38279) rubs on the cylinder block (Figure 2), file or grind off the latch as shown in Figure 3.

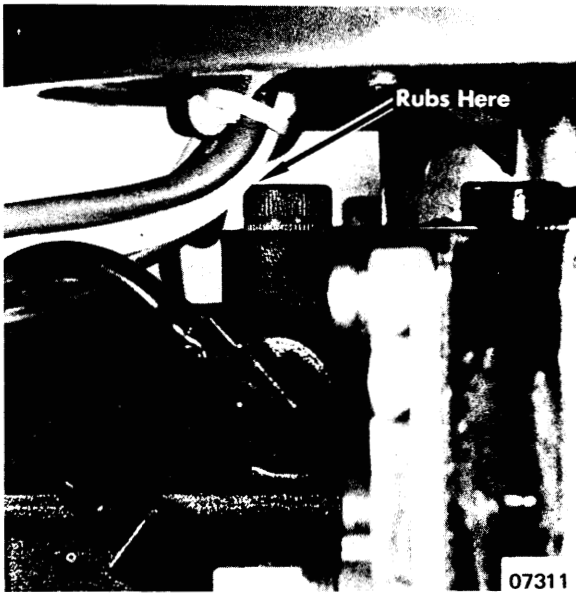
Figure 4. Ignition Module Leads

Ignition module leads on the 1972 Merc 200 may rub on the upper end cap right rear fastening screw. (Figure 4) If this chaffing is observed, remove sta-strap and re-install a new sta-strap, as shown in Figure 5, which will pull leads up and allow more clearance between leads and end cap.

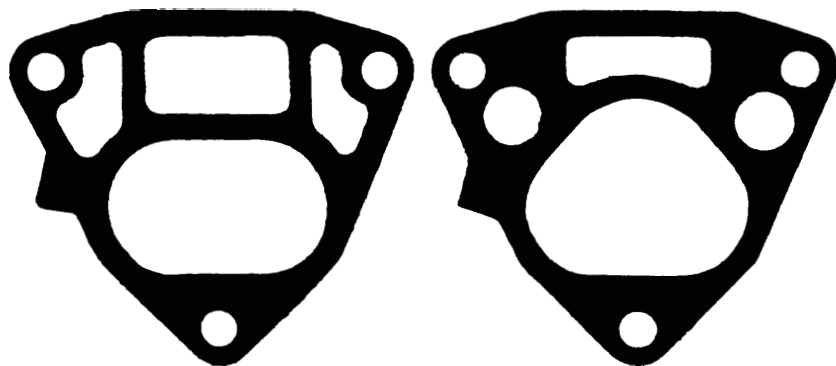
Figure 6. Fuel Pump Gaskets

There have been numerous occasions on which the wrong fuel pump diaphragm kit was installed on an outboard. Figure 6 portrays the differences in fuel pump gaskets and lists the models on which they are used.

A-55278A2
DIAPHRAGM KIT
Morc 800 Single Pump

A-55278A1
DIAPHRAGM KIT
Morc 400
Morc 800 * Dual Pumps
Morc 1150 * 1350 * 1400
