- A. Radio Noise Interference Suppression Spark Plug
- B. Remote Control Attaching Kit - 1972 Merc 200 Model
- C. Distributor Cap Clamp Installation
- D. Wiring Diagram - 1972 Merc 800 Operator's Manual
- E. Throttle Flex Shaft Rubbing - 1972 Merc 110-75 Models
- F. Ignition Coil Return - Part No. A-336-4409A1

E. THROTTLE FLEX SHAFT RUBBING - 1972 Merc 110-75 Models

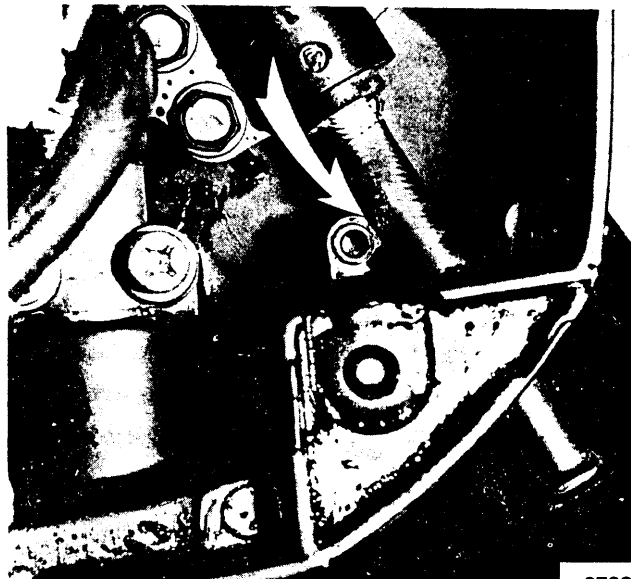
Figure 1.

Model 1972 Merc 110 engines (Serial No. 3269072 and below) and 1972 Merc 75 engines (Serial No. 3282747 and below) require that the bottom cowl be reworked to prevent chaffing of the throttle flex shaft. A portion of the screw boss on the bottom cowl must be filed or ground-off as shown in Figures 1 and 2.

Flat rate for this modification will be 0.3hrs.
