SERVICE Bulletin

MERCURY OUTBOARDS

Number: 78-2

Date : 10/25/77

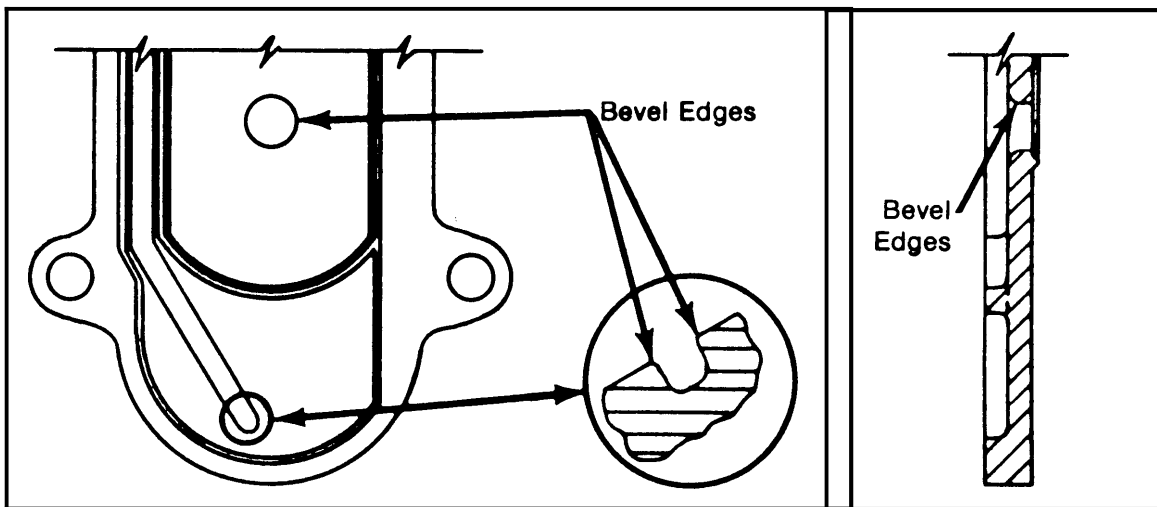
Figure 1. Beveled Edges Location

Occasionally, a diaphragm in a Merc 1750 fuel pump may split. Revisions have been made in the fuel pump pulse chamber (A-67622) to prevent this from happening. If fuel pump diaphragm splitting is experienced, however, bevel the edges of the slot and center hole, as shown in Figures 1 and 2. Also drill a .078" (5/64" or 2mm) diameter hole thru the pulse chamber, as shown in Figure 3.

Figure 2. Beveled Edges

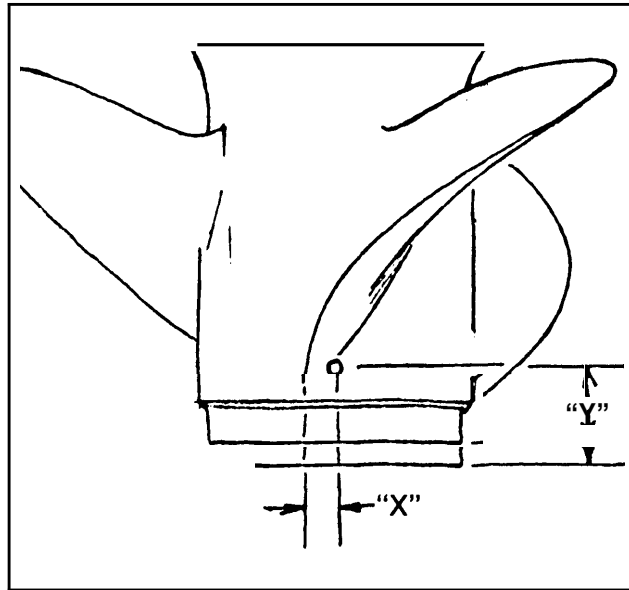
Figure 4. Hole Location

This modification works best on relatively high performance boats but may be found helpful on "normal" rigs (down to 17" pitch props) or on ski tow boats. It consists of drilling a small hole in the blade-root fillet near the leading edge. (See Figure 4 and chart, below.) The small hole allows exhaust gases to escape into the back side low pressure area and results in a controlled ventilation condition. In turn, this reduces the torque load on the engine, and the RPM will increase into a more favorable power range.

Merc Model	"X" Dimen.	"Y" Dimen.	Hole Diameter
1750	1/2" (12.7mm)	1" (25.4mm)	1/4" (6.4mm)
1500	1/2" (12.7mm)	3/4" (19mm)	3/16" (4.8mm)

WARNING: Drill thru outer hub only.
