service bulletin

MERCURY OUTBOARDS

NUMBER: 79-2

- A. Oversize Pistons and Rings - V150 and V175 Models
- B. Salt Water Corrosion - Gear Housing Bearing Carrier and Cover Nut
- C. Wiring Harness Ring Terminal Insulation
- D. Wear Sleeves - Crankshaft Salvage
- E. Starting Procedure - 1976 and Newer Merc 650-700-800-850

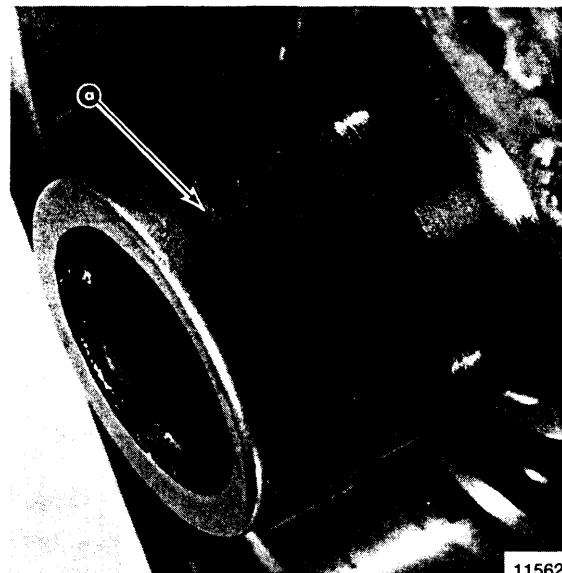
**Figure 1. Wear Sleeve
Installed on Crankshaft**

A new wear sleeve -- available to you in part numbers, below -- will salvage crankshafts on **3, 4** and **6**-cylinder models where corrosion has damaged the lower oil seal surface. See Figure 1 for wear sleeve installed.

a - Wear Sleeve

A-86348A1 Merc 40 thru 70 HP Models

8-86349A1 Merc 80 thru 200 HP Models
