NUMBER: 80-6

DATE: 1/31/80

- A. Use of Formula 50-D Oil in Older Mercury Outboards
- B. Starter Rewind Replacement Kit - Merc 40-50
- C. Vapor Lock Elimination - Merc 40-70
- D. Cleaning Gear Housing Speedometer Pickup

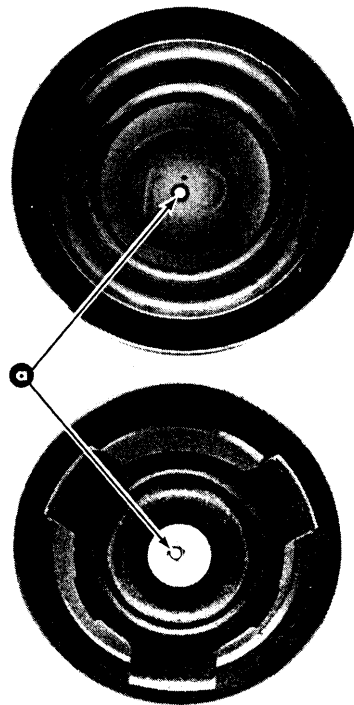
**Figure 1. Hole in Check Valve**

Occasional complaints are heard from customers regarding fuel vapor locking of Merc 40 and 70 outboards during very hot weather. This usually causes the engine to die on acceleration after it has been run and then shut down for a short time. To eliminate this problem, drill a .031" dia. (No. 68 drill) hole in the center of both fuel pump check valves. (Figure 1) If you do not choose to drill the holes, the check valves can be replaced with new check valves (Part No. C-21-92346A3).

a - .031"(1/32"or .787mm) Hole Drilled in Check Valve

**C-21-92346A3      Check Valve Kit**
