- A. Vapor Lock Problem * Model 40 and 402
- B. Cracked Cap Style Connecting Rods * Model 40/70/80/90/ 115
- C. Retorquing of Cylinder Heads * All V-6 Outboards
- D. Drive Shaft Usage Part Number 45-69251 * 6 Cylinder In-Line 140/1500
- E. New Service Tools for 1984 Model 75/90/115 with Power Trim
- F. Model 80-200 * Ignition Coil Test Procedure

NUMBER: 84-1

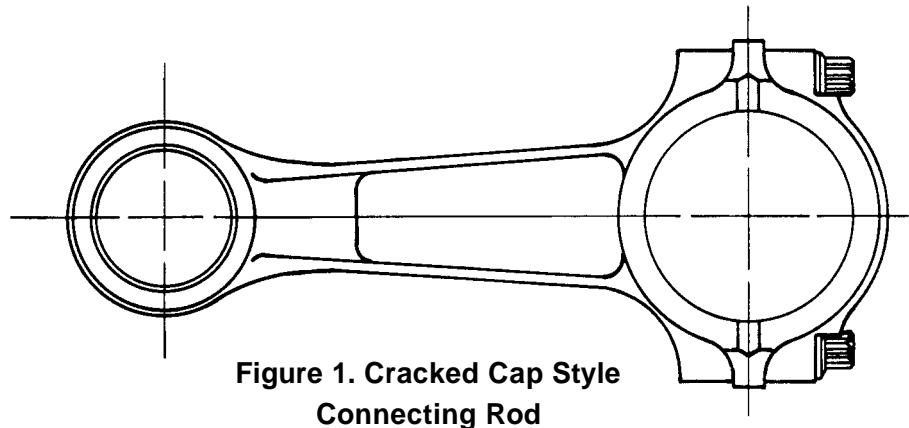
Current model 40/70/80/90/115 outboards are now using the cracked cap style Connecting Rod, Part No. 624-8101A3, Figure 1.

Figure 1. Cracked Cap Style
Connecting Rod

The cracked cap style Connecting Rod, Part No. 624-8101.43 supersedes and will backfit for Connecting Rod, Part No. 622-4850A3 (Figure 2) for all applications. DO NOT, however, use the old machined cap rod, Part No. 622-4850A3 in any current engine using the new cracked cap rod. The new rod extends bearing life considerably.

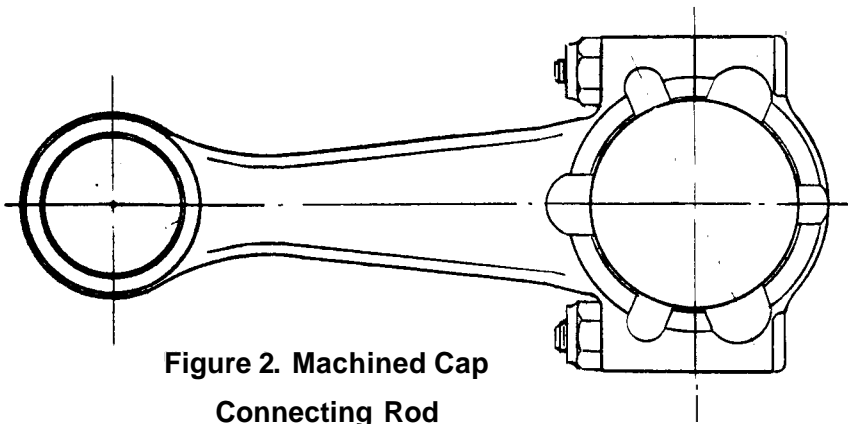
Figure 2. Machined Cap
Connecting Rod

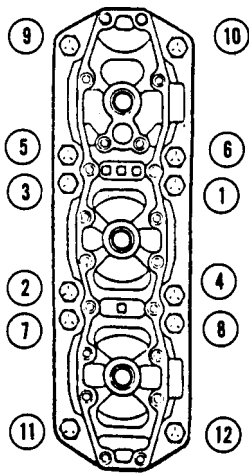
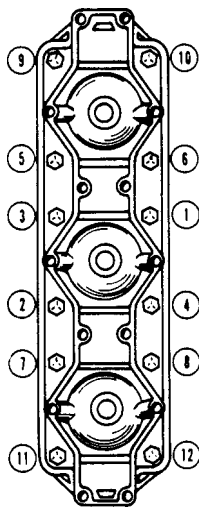
Figure 3.

Type 1
 40 Lbs. Ft. (54.2 N.m)
 Add Light Oil to Threads

Type 2
 30 Lbs. Ft. (40.7 N.m)
 Add Light Oil to Threads

Retorque head bolts after engine has been run approximately 3 hours
