- A. Over-Rich Running - Mariner/Mercury 60 (3 Cyl.)
- B. Vent Screw - Fuel Tank Cap - Mercury 2.2 and 4
- C. Warning Horn Sounding a Low Tone - Mercury 35 and Mariner/Mercury 45-60 and 115 Electric Start Models

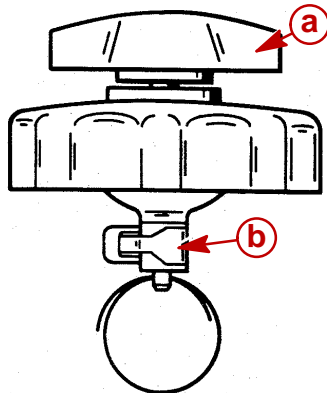
**Figure 1. Fuel Tank Cap**

We have received a few reports that the fuel cap vent screw does not operate **correctly**. **Turning** the vent screw (Figure 1) is limited to 1/4 or 1/2 turn. When released, it returns (snaps back) to the original position. This usually occurs the first time the fuel tank is attempted to be vented.

- a - Vent Screw
- b - Metal Clamp

1. Remove fuel tank cap from fuel tank.
2. Inspect the position of the metal clamp (Figure 1). The bottom of the metal clamp must be even with or very close to the bottom of the sealing rubber. Reposition the metal clamp if necessary.
3. With a sharp knife, cut through the sealing rubber to the screw shaft just above the metal clamp and separate (Figure 2). Do not remove the metal clamp and the rubber piece thee it holds.
4. Re-install the fuel tank cap.

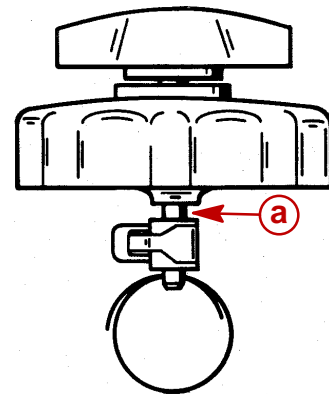
**Figure 2. Fuel Tank Cap**

- a - Cut and Separate

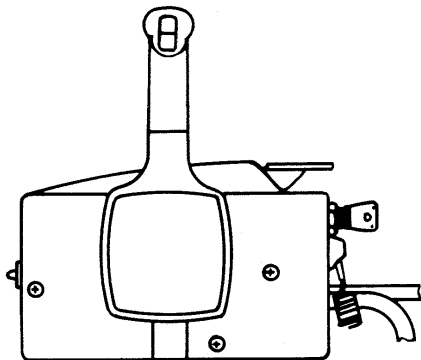
**Figure 3. Quicksilver 2000 Remote Control**

Warning horn sounding a low tone when the engine is running may be caused by electrical RFI (radio frequency interference) from the engine. This only occurs when the Quicksilver 2000 remote control (Figure 3) with the warning horn inside is used with the P/N 13019--4 AutoBlend. Although all 1988 Mercury 35 and Mariner/Mercury 45,50,60 and 115 electric start models are shipped with this series remote control and AutoBlend, we have received only a few complaints.

Replace warning module on 13019--4 AutoBlends with latest warning module (P/N 19265) if all of the items apply:

1. Warning horn sounds a low tone only when engine is running.
2. Remote control is a Quicksilver 2000.
3. Lot number is BJ or previous, i.e.: BI, BH, BG, etc.
4. Warning module does not have a round green sticker
5. Warning module does not have a letter "M" molded into the case.

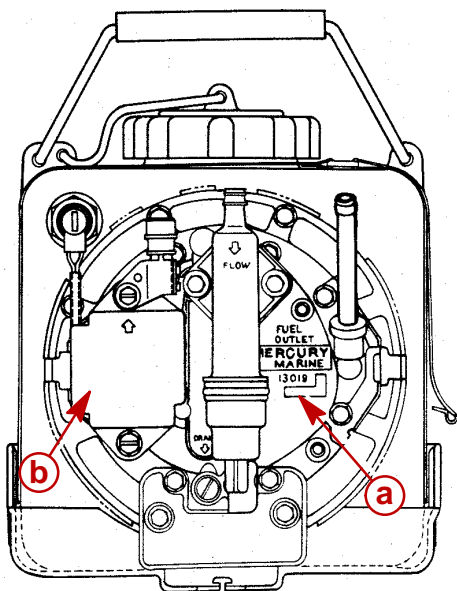
**Figure 4. AutoBlend 13019--4**

An improved AutoBlend electronic module (P/N 19264) that eliminates the affect of RFI has been installed on AutoBlends midway through the manufacture of lot #BJ (Figure 4). To identify the improved module, a round green sticker (Figure 5) has been applied to the module case.

- a** - Lot Number Location
- b** - Module

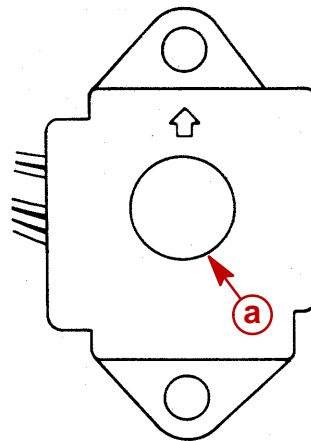
**Figure 5. AutoBlend Module P/N 19264**

- a** - Round Green Sticker

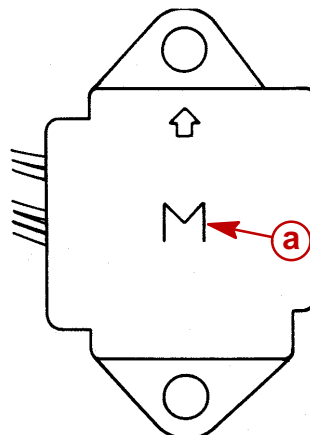
**Figure 6. AutoBlend Module P/N 19265**

A further improved module (P/N 19265) will be installed on AutoBlends starting with foe code CA and can be identified by a letter "M" molded into the module case (Figure 6).

- a** - "M" Molded into Case
