- A. V6 Oil Injection Pumps - P/N 41032 & 41033
- B. Throttle Lever and Linkage Wave Washer Removal Models 70-75-80-90-100
- C. Merc 4 & 5 & 102cc Sail Power Field Service Kit (Temperature Control) Part No. 813142A1

**A. V6 OIL INJECTION PUMPS -  
P/N 41032 & 41033**

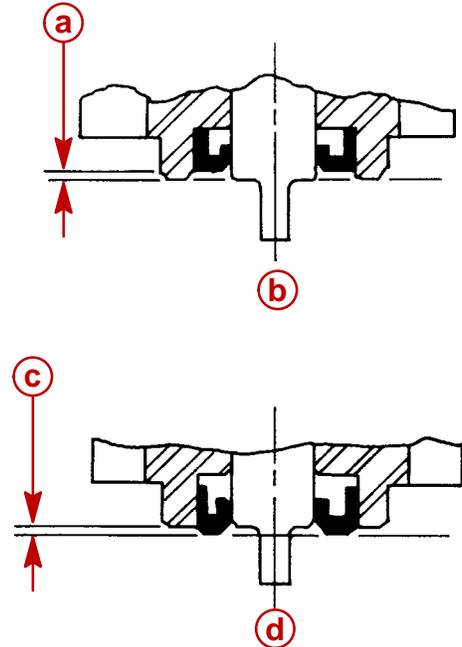
**Figure 1.**

It has been determined that failure of the crankshaft plastic drive gear can be caused by the seal in the oil injection pump backing out. Figure 1. When the pump seal backs out, it loads the driven gear and plastic drive gear causing excessive wear. Future injection pumps will have the seal staked in place.

- a** - Flush to Depressed
- b** - Reuse
- c** - Raised
- d** - Replace

Should a customer have the plastic oil injection drive gear damaged on their V6 outboard, it will be necessary to inspect the oil injection pump. If the seal is backed out, it will be necessary to replace the worm bushing - P/N 814103. Figure 1.

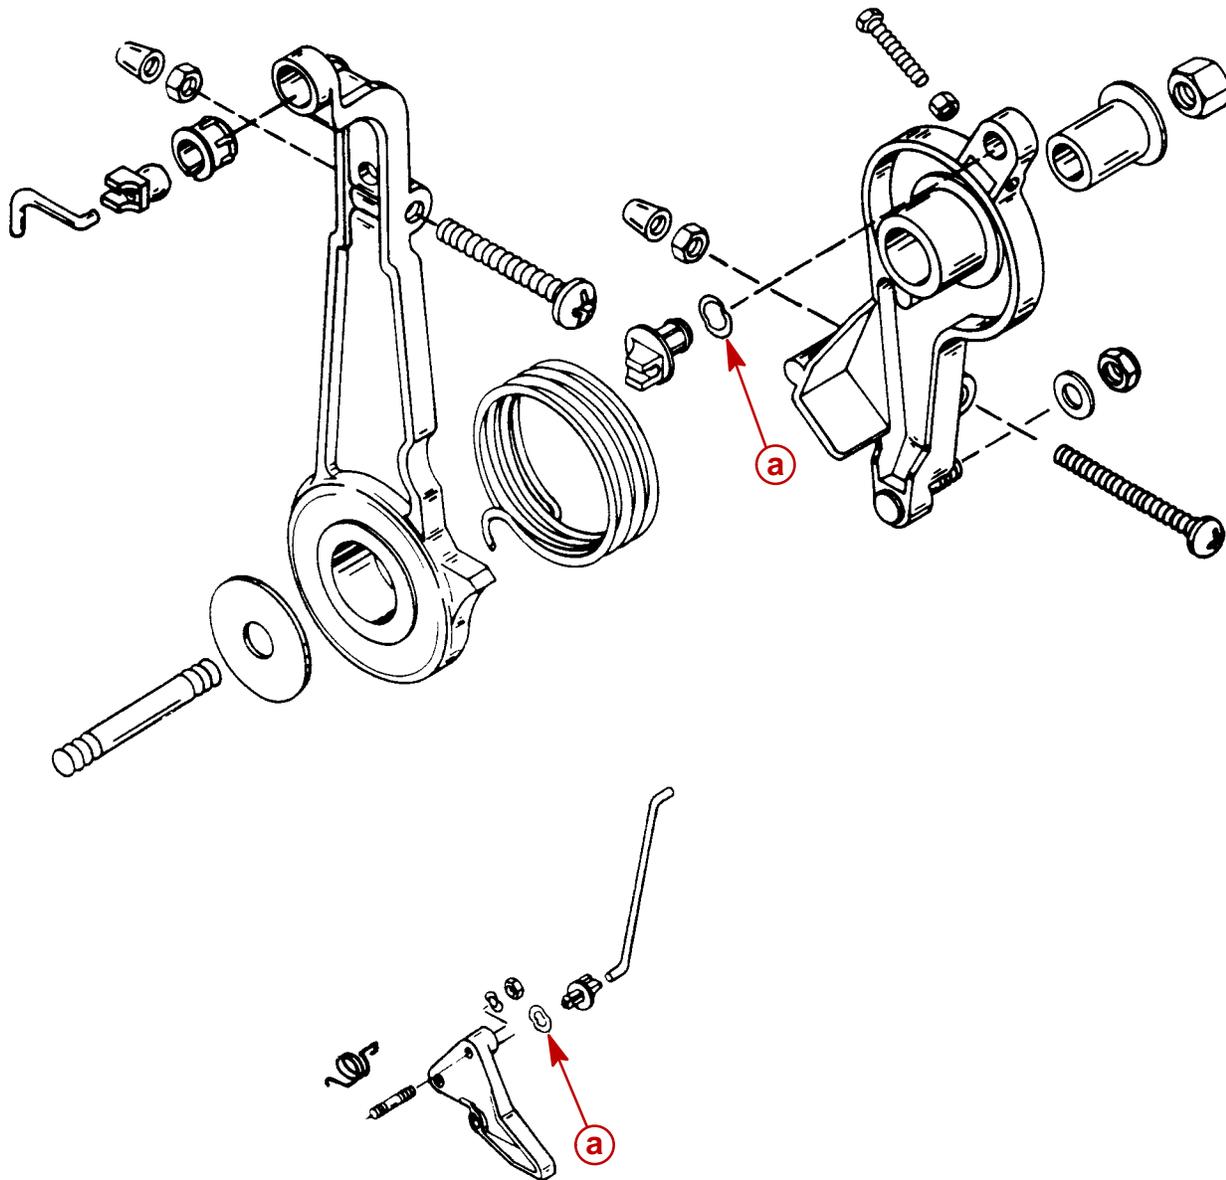
a - Remove

When servicing 3 cylinder model 70-75-80-30 and 4 cylinder 100 HP outboards for any reason, remove the wave washers from the swivel bushings. Figure 2. Removal of the wave washers will prevent the swivels from breaking during removal, installation. Future production outboards will have the wave washers removed.
