GEARCASE FAILURES - 75 thru 125

This is a revision of Outboard Service Bulletin 96-17. Destroy existing Bulletin 96-17 and insert revised Bulletin 96-17.

1995, 1996 and 1997 Mercury / Mariner 75 thru 125 HP Models, serial number
USA 0G077367 thru 0G589999
BELGIUM 9836633 thru 9973099

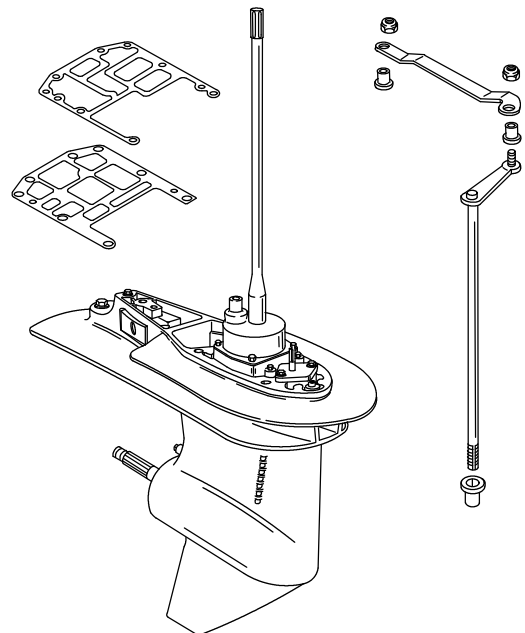
Replacement gear housing assembly components

Installation of a new 6-jaw clutch style gear housing assembly on non-tiller handle models will require the installation of a new upper shift shaft and shift link arm which involves powerhead removal. The new upper shift shaft, new link arm, and installation instructions are shipped with the gear housing assembly. The installation instructions will show by model which new shift part(s), if any, requires installation.

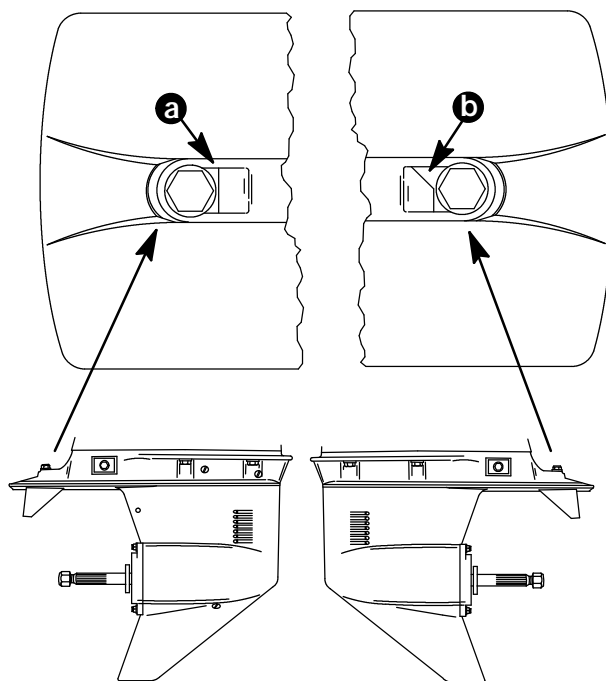
Identify gear case design to ensure correct components are being installed. Design I - "3 Jaw Reverse Clutch" (a) gear case identified with straight machined edge for trim tab screw mounting surface. Design II - "6 Jaw Reverse Clutch" (b) gear case identified with angled machined edge for trim tab screw mounting surface.

a - Design I - "3 Jaw Reverse Clutch" Gear Case Identifier
b - Design II - "6 Jaw Reverse Clutch" Gear Case Identifier

After the "6-Jaw Reverse Clutch" gear housing and updated Shift Shaft have been installed replacement parts **MUST** be ordered from the "6-Jaw" section of a 1998 model year and newer parts list. "3-Jaw" and "6-Jaw" reverse clutch parts are **NOT** interchangeable.
