Idle Relief Restriction – 75 thru 250 Hp

Mariner/Mercury 75 thru 250 HP

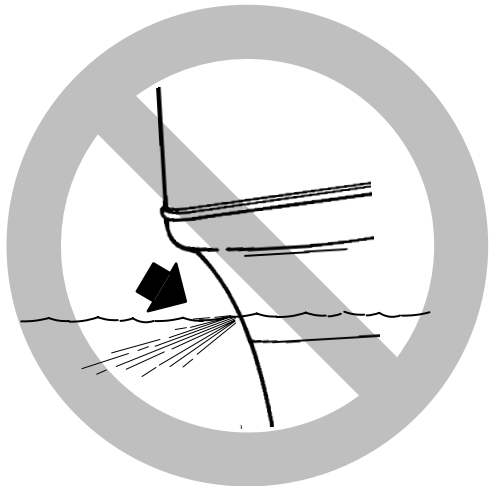
Poor engine performance may be caused by submersion of the exhaust relief hole. Submerging the idle relief hole can cause an exhaust restriction that may cause poor acceleration, poor idle, excessive smoke, and fouled spark plugs.

Outboards installed too low on the transom can ingest water and cause engine damage which is not covered by warranty.
