## Camshaft Oil Seal Replacement - 45/50 (4-Stroke)

1995 and 1996 Model 45/50 (4-Stroke)

Serial Number USA 0G382347 and Below

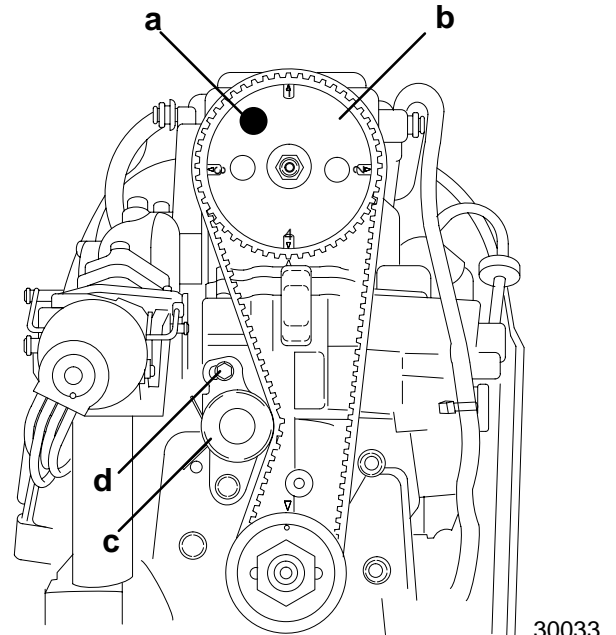
**Figure 1. 45/50 Rework Identification Marking**

- A black paint dot on the camshaft driven gear (Figure 1).

- a - Black Paint Dot
- b - Camshaft Driven Gear
- c - Belt Tensioner
- d - Belt Tensioner Fastening Bolt

8. Reinstall camshaft driven gear and timing belt as outlined in outboard service manual.
9. Apply a black paint dot on the camshaft driven gear as shown in (Figure 1) to indicate a repaired seal.
10. Allow Loctite to cure overnight before placing unit into service.

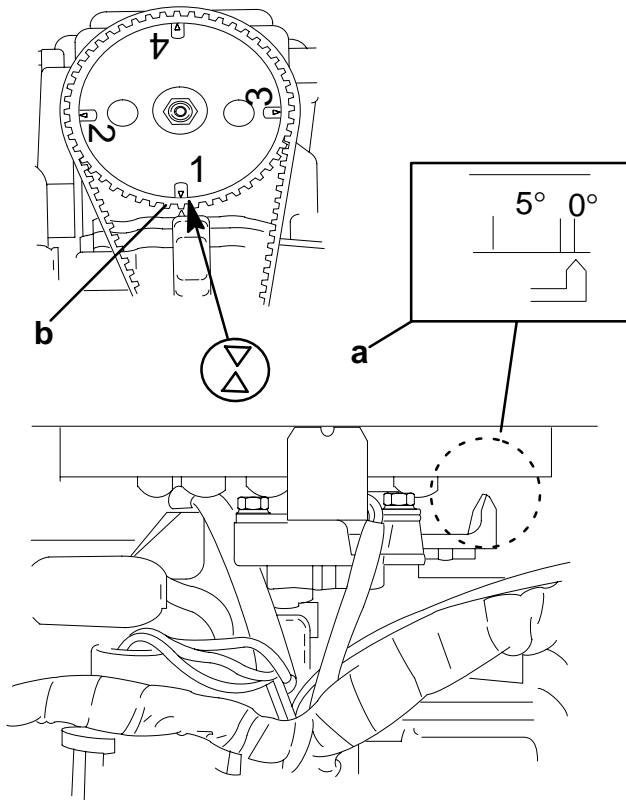
**Figure 2. Timing Pointer Alignment**

- a - Flywheel Timing Mark 0° (TDC)  
b - Camshaft Driven Gear Timing Mark - Cylinder Number 1

1. Rotate flywheel clockwise to align the 0° (TDC) timing mark with the timing pointer (Figure 2).

**IMPORTANT: Both the flywheel and the camshaft driven gear must be aligned with their alignment marks when installing the timing belt. (Figure 2)**

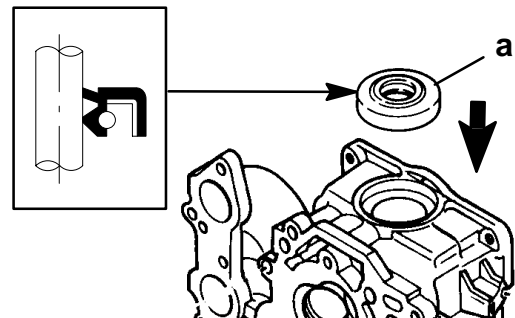
**Figure 3. Securing Upper Camshaft Seal**

The listed 1995 and 1996 Mercury and Mariner outboards may have a loose fit between the upper camshaft oil seal and the seal bore in the cylinder head. Seals have pushed out of position creating a major oil leak which could cause a powerhead failure.

- a - Upper Camshaft Oil Seal  
b - Chamfer Around O.D. of Oil Seal

7. Dry the area and apply a continuous bead of Loctite 499 Super Bonder (Quicksilver p/n 92-852882) into the chamfer around O.D. of the oil seal and I.D. of the seal bore (Figure 3).
