Overheating – 3 Litre

MERCURY AND MARINER

1994 thru 1996, 225/250 HP, 3.0 Litre
S/N 0D280813 thru S/N 0G437999

1997 200 HP DFI
S/N 0G386496 thru 0G509800

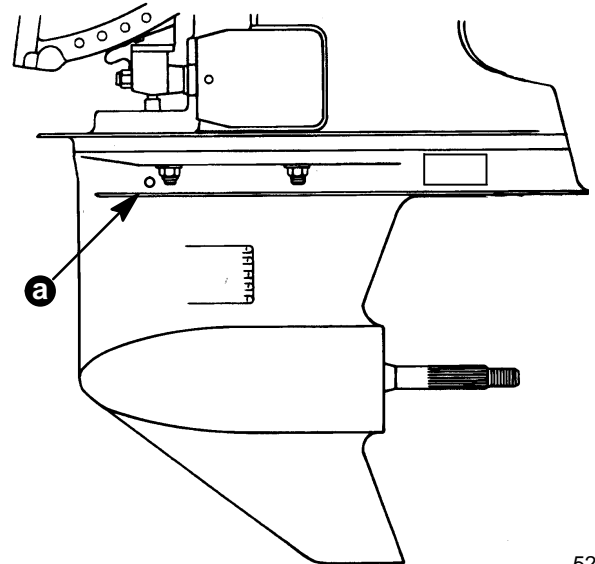
52374

There have been occasional reports of 3.0 Litre engines overheating. The customer will report hearing a warning horn, and engine rpm will drop to about 3000. Typically this occurs on large boats, when operated between the 2500 to 4500 rpm range. Normally this overheat condition is not consistent, occurring occasionally. If this problem is reported, check the following.

a - Drain hole drive shaft housing (one each side)

If the overheating condition continues after the above items have been checked, restrict the drive shaft housing drain holes as outlined, using a 1/16 inch pipe plug P/N 22-56800.

1. Cut threads into the drive shaft housing drain holes located on each side of the lower unit, using a tapered 1/16 inch 27 NPTF pipe tap.
2. Apply Loctite #271 (P/N 92-809820) to the threads of plug P/N 22-56800.
3. Install plug P/N 22-56800 so head of plug is even/flush with the surface of gear housing.
4. Drill a 1/8 inch (3.17mm) hole through the center of the plugs.
5. Paint over the plug with touch-up paint.

NOTE: The two drilled plugs will restrict the water that will exit the drive shaft housing. This will insure that proper water level is maintained above the water pump, preventing air from being drawn into the cooling system through the water pump.

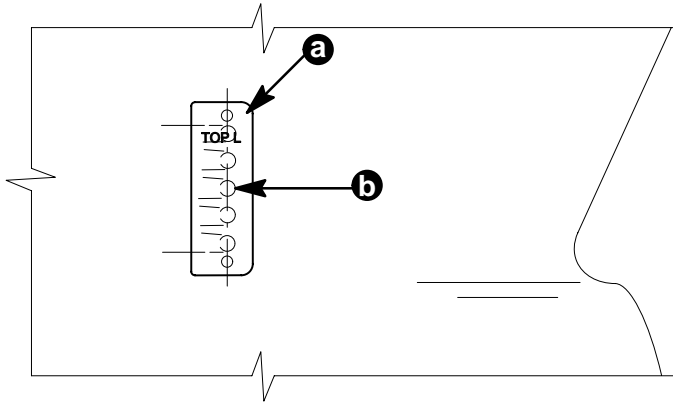
- a - Water pickup
- b - Intake holes

On some applications large amounts of air-ventilated water may occur. If overheating reoccurs after the drive shaft housing drain holes have been restricted, install a high speed water pickup kit P/N 832066A1 (Installation Instructions included with kit).
