Sta-Strap Interference with Throttle Cable Sleeve – 1992 75 thru 115

MARINER AND MERCURY

S/N 0D096367 thru 0D107109

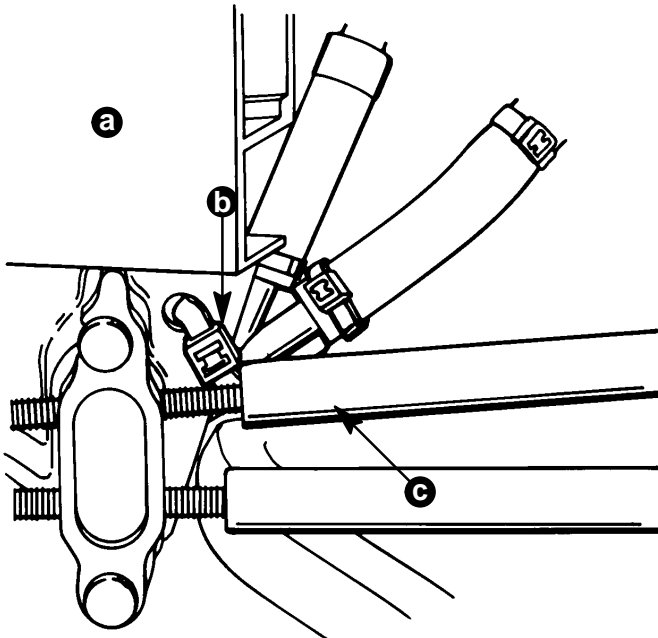
51544

Inspect the sta-strap that holds the fuel line to the carburetor air intake. If the sta-strap locking tab is pointing straight out, it may contact the throttle cable sleeve at full throttle. This contact may prevent full throttle operation.

- a - Carburetor Air Intake
- b - Sta-Strap
- c - Throttle Cable Sleeve

Sta-Strap Locking Tab Contacting Throttle Cable Sleeve

Turn the sta-strap until the locking tab is down and can not contact the throttle cable sleeve.

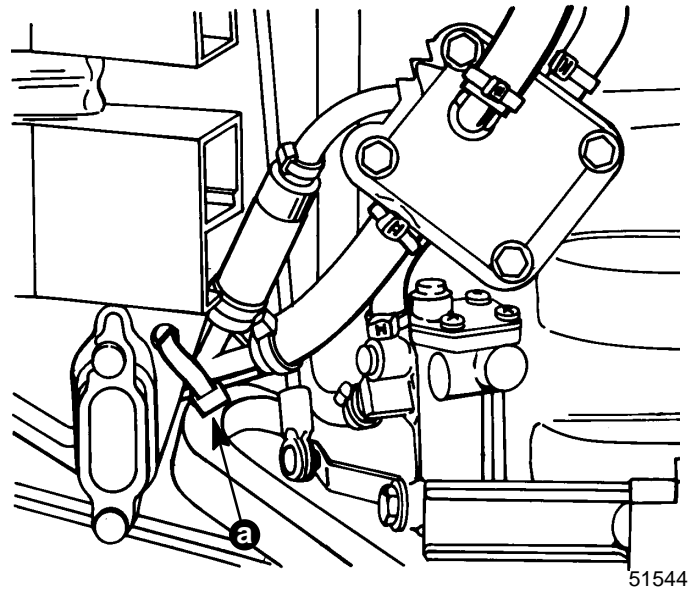
51544

a - Sta-Strap

Sta-Strap Locking Tab in Correct Position
