Relocation of Gear Housing Vent Hole – 1991 75 thru 115

Mariner and Mercury 75-115

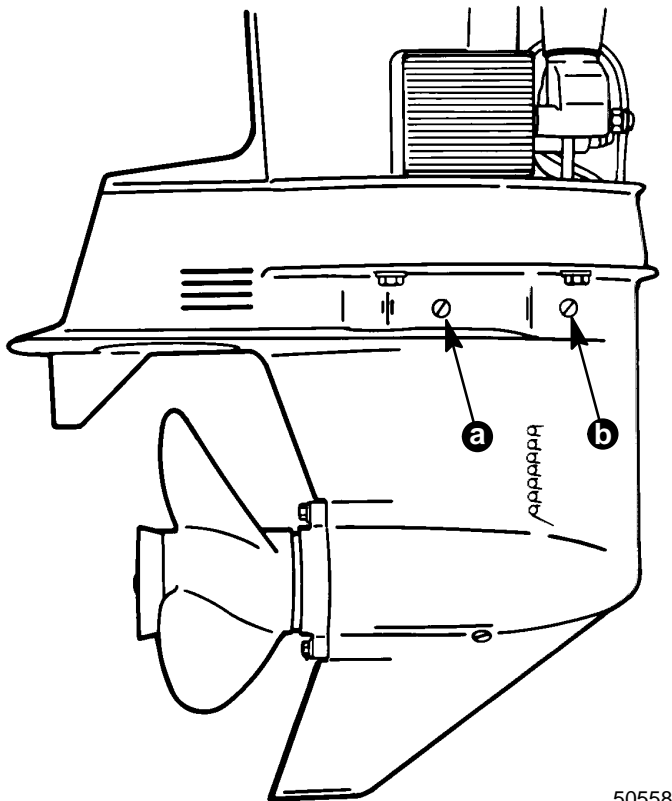
Figure 1. Previous Gear Housing with Vent Holes At the Same Level

a - Rear Vent Hole Marked "VENT"
b - Forward Vent Hole Not Marked

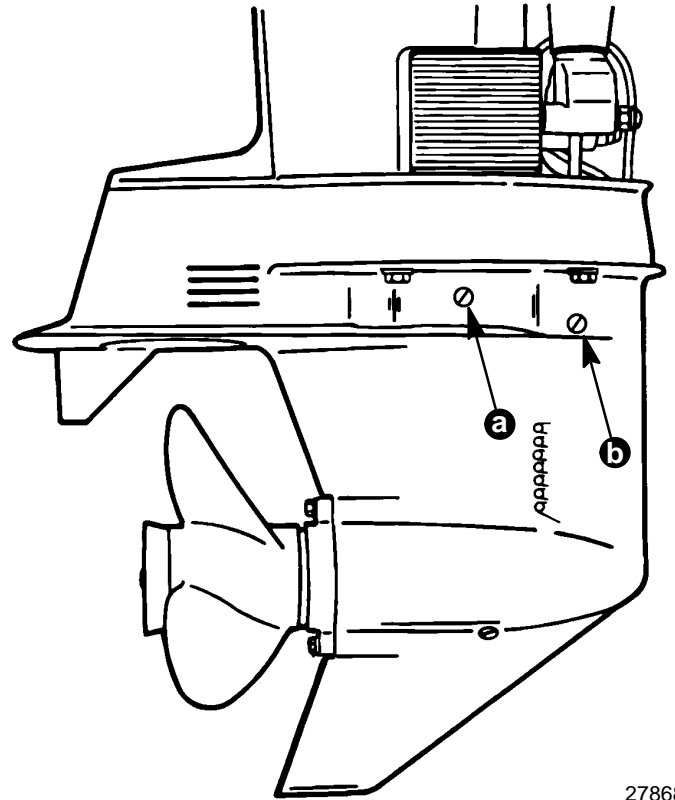
Figure 2. New Gear Housing

The gear housing forward vent hole on outboards listed has been lowered. Lowering the forward hole will allow for a wider range of acceptable lubricant level. Lubricant level can be as high as the rear upper vent hole and as low as the forward lower vent hole. Beginning production of the lowered front vent hole gear housing did not have that hole labeled. Later production has "OIL LEVEL" next to the forward vent hole.

a - Rear "VENT" Hole
b - Forward "OIL LEVEL" Vent Hole

FILL – Remove the fill, forward vent and rear vent plugs. Inspect and replace the plug gaskets if necessary. Always fill the gear housing from the bottom fill hole. Fill the gear housing until some lubricant runs out of the forward vent hole and install the forward vent plug and gasket. Continue to fill until the lubricant runs out of the rear vent hole and install the vent plug and gasket. Remove the lubricant applicator from the fill hole and install the fill plug and gasket.

LEVEL CHECK – Remove the forward vent plug. Lubricant should run from the hole. If it does not, perform the fill procedure.
