MERCURY OUTBOARDS

service bulletin

No. 91-20

Flywheel Replacement – 1991 40 (4 Cylinder)

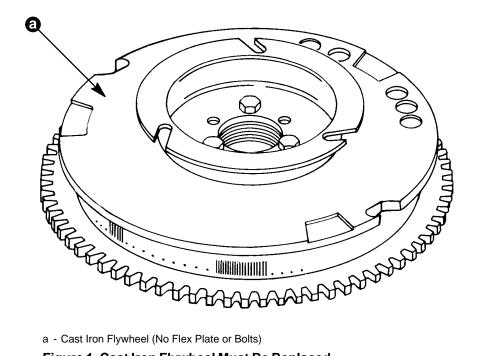
Figure 1. Cast Iron Flywheel Must Be Replaced

a - Cast Iron Flywheel (No Flex Plate or Bolts)
