## Slow Trim/Tilt Rate - 1992 75 thru 115

1992 75 thru 115

Single Ram Power Trim  
with Date Code 11310 and Earlier

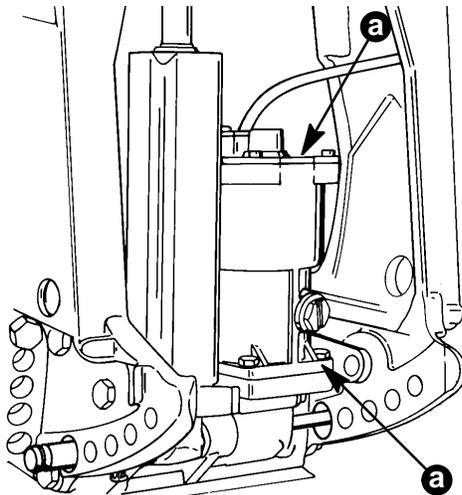
**Figure 1. Single Ram Power Trim**

Some single ram power trim units with date code 11310 and earlier may trim/tilt at a slower rate than designed. Refer to INSPECTION following to determine if the power trim unit is slower. Newer units with date code 11311 and later have recessed check valves to correct the slow trim/tilt rate.

a - Date Code Locations

Date code on power trim:

1	1	3	1	1
Shift	Year	Day of the Year		
1	1991	November 7

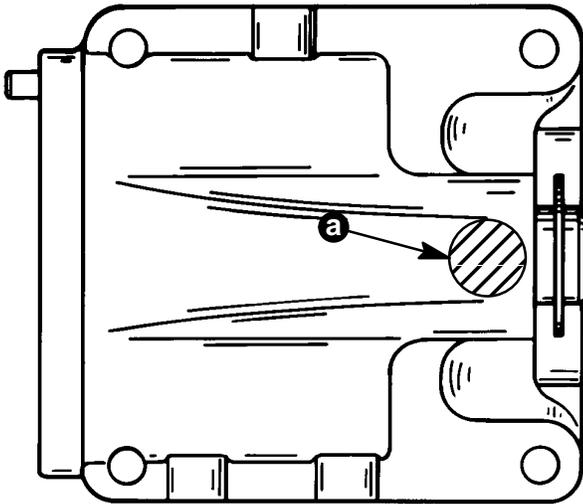
**Figure 2. Bottom View of Pump/Manifold**

Replace pump/manifold using one of three improved service replacement assemblies. Pump/manifolds P/N 811670 with improved check valves are identified by a white dot on the bottom on the manifold. Pump manifolds P/N 811670--1 and 811670--2 have the check valve improvement and are identified by a green paint mark on the top of the manifold next to the trim/tilt cylinder mating surface as well as the white dot on the bottom of the manifold.

a - Location of White Dot.

P/N 811670 - Pump/Manifold which is NLA  
White paint dot on the bottom

P/N 811670--1 - Pump/Manifold which is NLA  
White paint dot on the bottom  
Green paint mark on the top

P/N 811670--2 - Pump/Manifold with pilot relief valve  
White paint dot on the bottom  
Green paint mark on the top
