MIERCURY Outboards

No. 92-12

Power Trim Rocker Arm – 75 thru 115

1992 75 thru 115 Power Trim Models

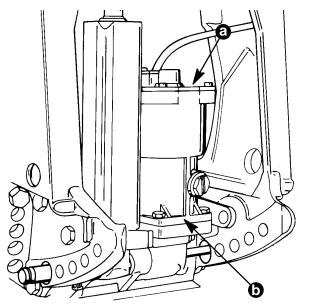
Figure 1. Locations of Date Code

Power Trim Date Code 12003 and Earlier

a - Label on Top of Housing

Or b - Reservoir Stamp
