Gearcase Oil Slinger Eliminated – 1992 135 thru 200

Mariner and Mercury
1992 and newer
135 thru 200
S/N 0D154836 and above

Service Replacement Gearcase produced after 2/18/92

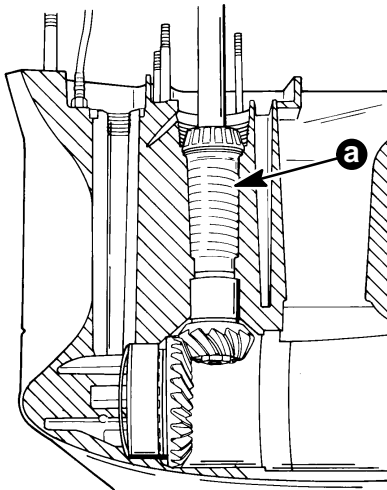
Figure 1. Oil Slinger Location

The gearcase oil slinger p/n 23-43998 is not installed in the gearcase on the models listed. This change was made in conjunction with enlargement of the oil circulation hole from 1/4 inch (6.3 mm) diameter to 3/8 inch (9.5 mm) diameter. The enlargement of the oil circulation hole was made prior to removing the oil slinger to eliminate any assembly error.

a - Oil Slinger

Gearcases with a 1/4 inch (6.3 mm) oil circulation hole must continue to have the oil slinger installed.

IMPORTANT: Gearcases with the 1/4 inch (6.3 mm) diameter oil circulation hole REQUIRE the oil slinger p/n 23-43998 to provide lubrication to the upper bearing.

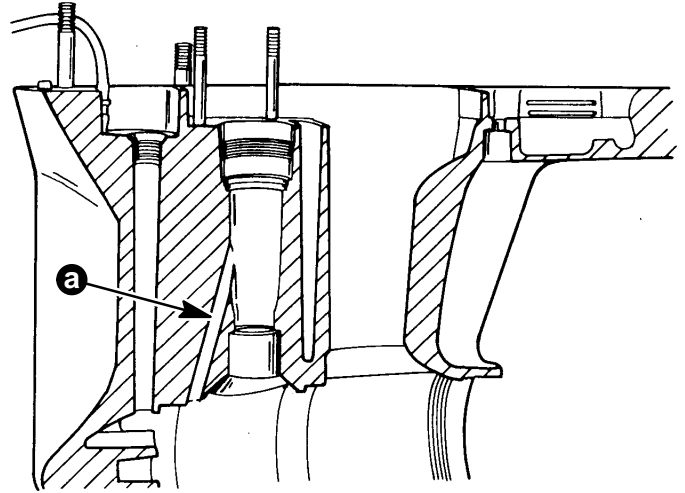
Figure 2. 135 thru 200 Gearcase

The oil circulation hole connects the torpedo area to the upper drive shaft bearing area.

a - Oil Circulation Hole

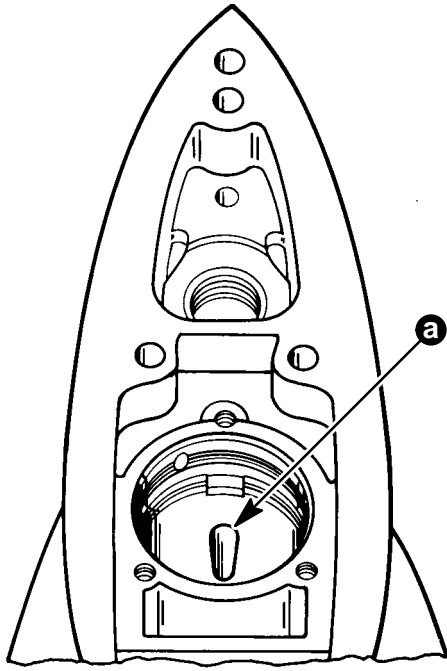
Figure 2. Top View of the Gearcase

a - Oil circulation Hole

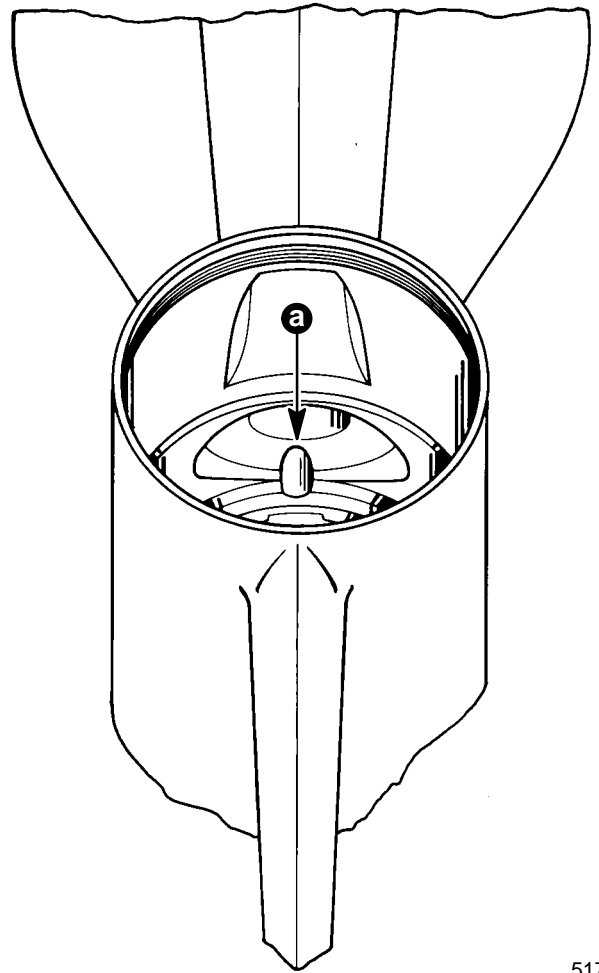
Figure 3. Rear View of the Gearcase

a - Oil Circulation Hole
