Detonation Sensor and Module – 1993 200 Magnum EFI/XRi

1993 Mariner 200 Magnum EFI
1993 Mercury 200 XRi
S/N 0D239648 thru 0D270353

Mariner and Mercury
200 and 220 EFI Models
S/N 0D239647 and below
with Replacement Gray Detonation Sensor Installed.

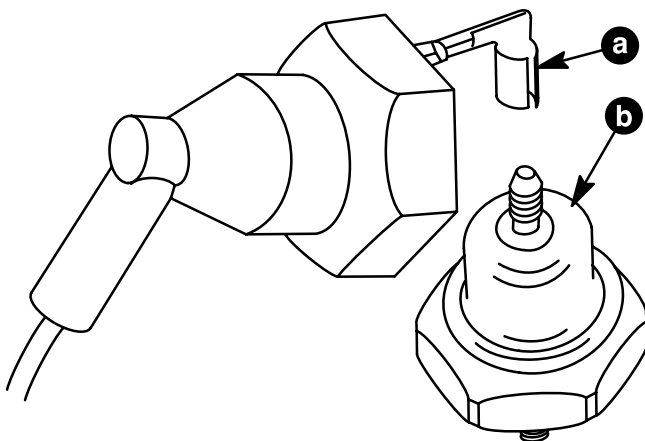
Figure 1. Detonation Sensor

Models listed require installation of an improved detonation module p/n 14856A11 (stamped 14856A10). Beginning with serial number 0D239648 a detonation sensor with a gray dome was installed on 200 Magnum EFI and XRi models. The previous detonation sensor with a black dome is no longer available. We have found that some outboards with the new gray sensor and the 14856A5 or the A8 detonation module may be operating in the “detonation” mode at engine speeds above 5500 RPM. The result of operating in this false detonation mode is a varying degree of reduced performance and possible high fuel consumption.

The improved detonation module eliminates the false “detonation” signal and is compatible with either the previous black or the new gray detonation sensor.

On models listed, remove the detonation module stamped 14856A5 or 14856A8 and install a service replacement detonation module p/n 14856A11 (stamped 14856A10).

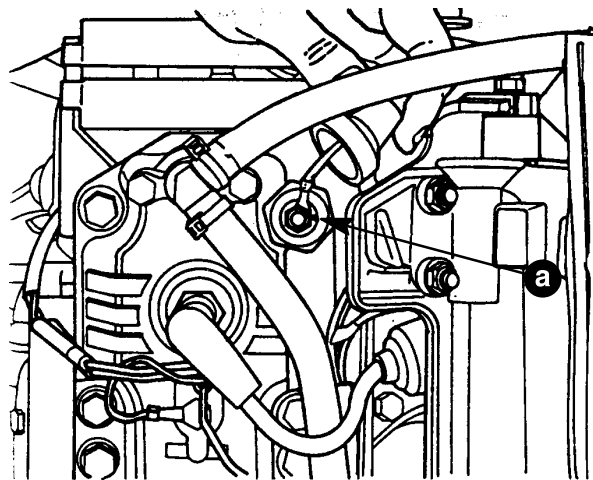
Figure 2. Detonation Sensor Location

- careful handling. The sensing element is fragile. A hard blow or dropping on a hard surface can destroy the sensing element.
- a proper torque when installing it in the cylinder head bolt. Sensor torque is 144 in. lb. (16.2 N-m). Over torque can destroy the sensing element.
- a secure wire connection to sensor terminal. The push-on split wire connector (Figure 1) may spread open when removing the connector from the sensor. It may be necessary to squeeze the split end of the connector to ensure a secure connection.

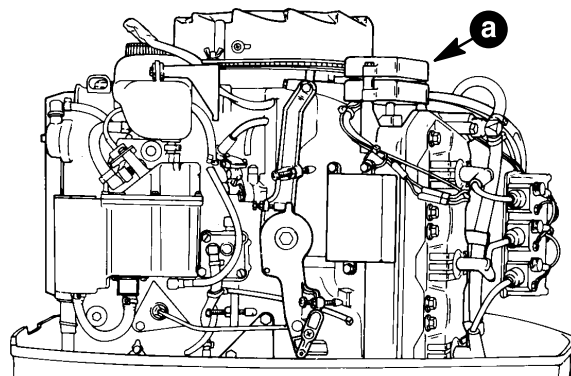
Figure 3. Detonation Module Location

Detonation Module The previous detonation module service replacement p/n 14856A3 supersedes to p/n 14856A11.
