Voltage Regulator Failures - 135 thru 200

Mariner and Mercury

1992 and 1993 135 thru 200

S/N 0D082000 thru 0D254352

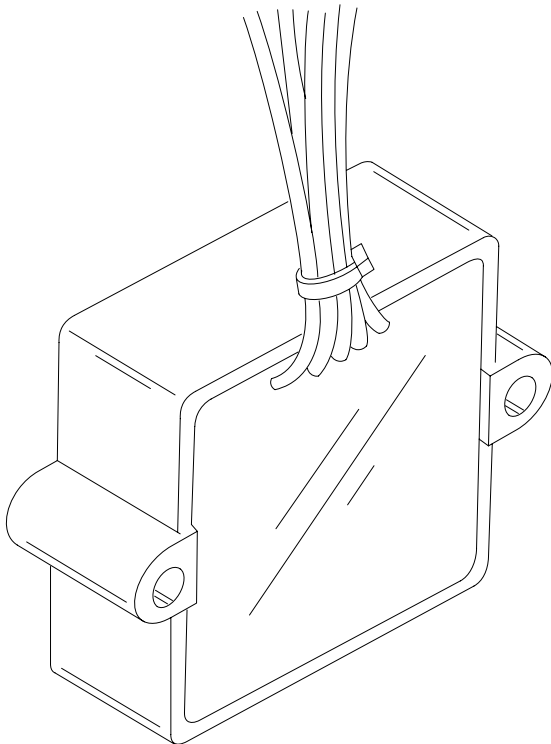
Figure 1. Voltage Regulator

The models listed have experienced a higher than normal number of voltage regulator failures. The cause has been found to be overheating of the regulator. This occurs when using a high amount of current and/or outboard operation in warm waters.

Models listed should have an adaptor p/n 824715 installed under both voltage regulators. The adaptor will allow the voltage regulator to fully contact the exhaust plate and dissipate the heat quicker.

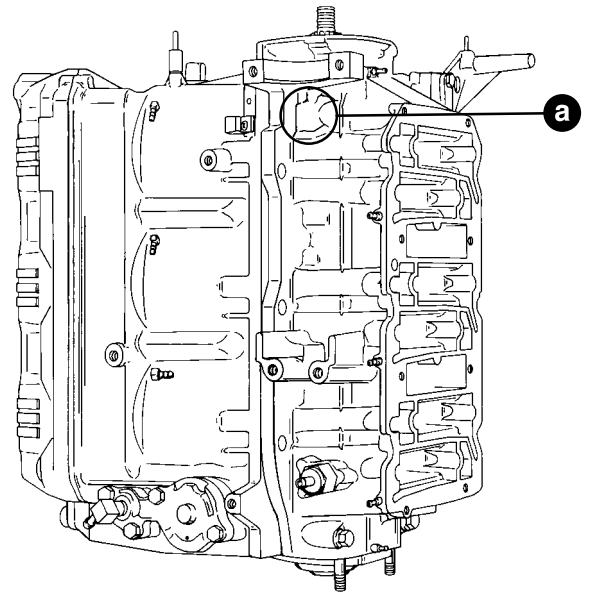
Figure 2. Date Code Location

Outboards starting with serial number 0D254353 and above and replacement powerheads with date code 1/23/93 and later (Figure 2) have an improvement to the exhaust plate to prevent the regulator from overheating. The improvement involves machining the voltage regulator mounting area to allow the regulator to fully contact the exhaust plate and allow the heat to dissipate faster and more efficiently.

a - Date Code 1/23/93 and Later.

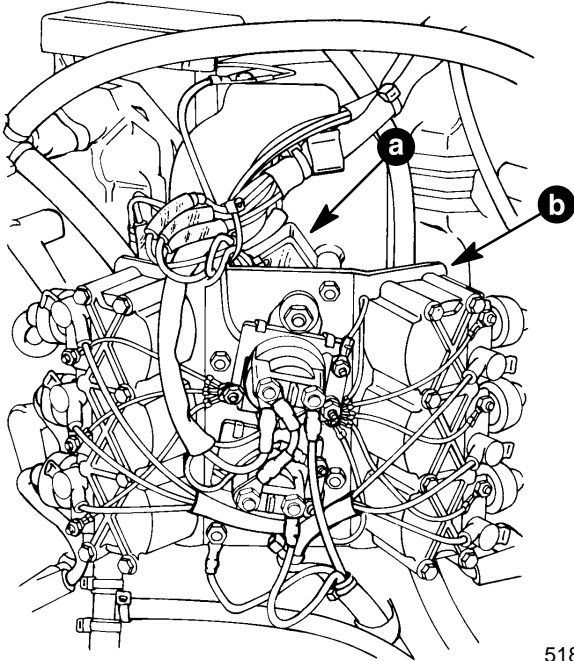
Figure 3. Voltage Regulator Location

a - Voltage Regulator.
b - Ignition Plate.

- removal of the ignition plate at the rear of the motor (Figure 3).
