SPORT JET 90 INFORMATION UPDATE

1993-1994 Sport Jet 90

S/N 0E009675 thru 0E095087

The following represents the most common customer and/or dealer problems and solutions on 1993-1994 Sport Jets.

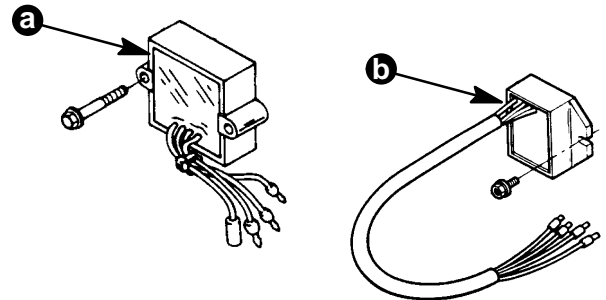
The voltage regulator has been identified as the cause of stator failures. New, higher capacity voltage regulators, listed below, have resolved stator failures. Sport Jets with serial numbers above 0E066619 have the latest regulators.

a - New Regulator

b - Old Regulator

Should a stator failure occur between serial numbers 0E009675 and 0E066619 replace the stator (p/n 8778A29) and the voltage regulator. The proper voltage regulator is listed below:

S/N 0E009675 thru 0E033710

Use regulator p/n 815279T 3

S/N 0E033711 thru 0E066619

Use regulator p/n 815279T 5

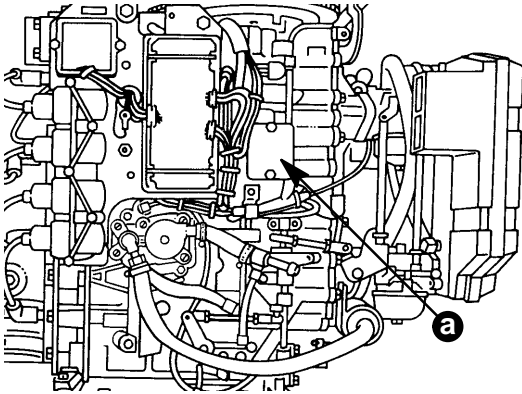
a - Rev Limiter

Faulty rev limiters can completely kill the ignition system, drop cylinders at a lower rpm, or allow engine to over rev. The rev limiter is designed to randomly drop cylinders so that the engine will not exceed 5800 rpm.

To isolate the rev limiter from the ignition system, disconnect the black/yellow lead from the rev limiter. Run the engine. If the problem is eliminated, the rev limiter is defective. The rev limiter p/n is 821889A18.

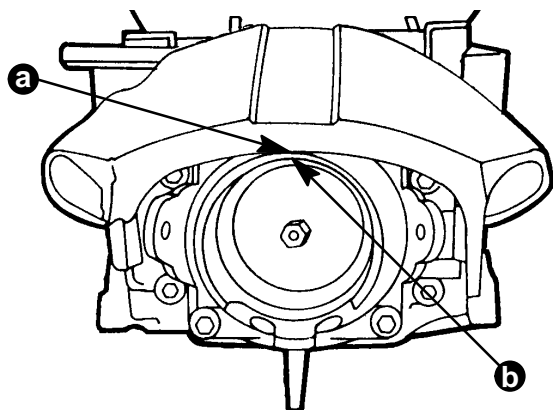
There is some normal vibration from idle up to planing speeds. Severe vibration, at all speeds, was found to be the result of the reverse gate interfering with the rudder water flow. The reverse gate must be adjusted so that in full forward position, the reverse gate bottom edge (a) clears the rudder opening (b).

a - Reverse Gate Bottom Edge
b - Rudder Opening

An improperly adjusted reverse gate will also result in loss of performance and/or a reverse gate forward stop failure. Refer to Service Manual 90-824724 for complete instructions on adjusting the reverse gate.

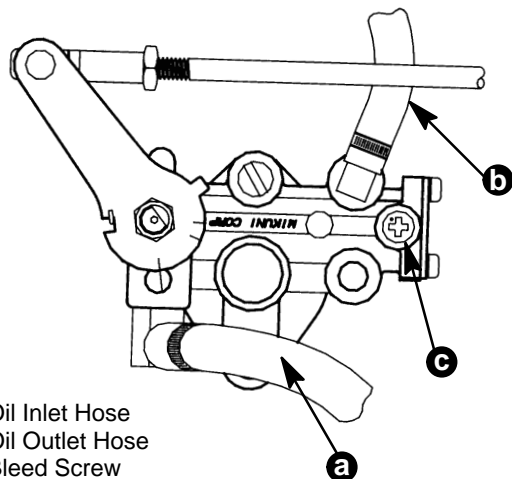
a - Oil Inlet Hose
b - Oil Outlet Hose
c - Bleed Screw

Powerhead failures can be caused by failure to bleed air from the oil lines. Check the oil line (a) from the reservoir to the oil pump. There should be no air in the line. If air is present, loosen bleed screw (c) and bleed air out until oil is present. Tighten bleed screw. The oil injection system is now operational.

Inspect the oil lines (a and b) for any kinks or sharp bends. Correct as necessary.

Check that all oil line connections are secured with sta-straps or clamps.
