service bulletin

Actuator Seal Failures - Quicksilver Power Steering

P/N 17443A2, A3, A7, A8, A10, A11

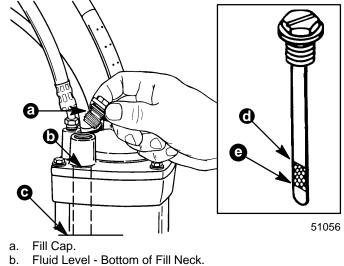
Figure 1. Fluid Level.

<u>Overfilling the Reservoir</u>. A caution decal has been developed to provide convenient instructions on how to check and maintain the oil level in the reservoir. Order caution decal p/n 37-826190 and install next to the oil fill hole on all in-stock and customer owned power steering units that do not have the decal. Also, explain the proper fluid checking/filling procedure to the customer.

- 1. Turn key off.
- 2. Release fluid pressure by steering thru the full steering range (stop to stop) three (3) times, then extend the steering ram full out.
- 3. Remove fill cap. NON-DIPSTICK MODELS: fill with fluid to bottom of fill neck (b). Actual fluid level in reservoir will be at the bottom of the fill tube (c). DIPSTICK MODELS: fill with fluid to the dipstick full mark (d). DO NOT OVERFILL.
- 4. Thread fill cap in two full turns. DO NOT TIGHTEN.
- 5. Turn key "ON". Activate the system by steering thru the full steering range (stop to stop) three (3) times, then extend the steering ram full out. DO NOT REFILL OIL RESERVOIR.
- 6. Tighten fill cap with steering ram extended full out.
