Powerhead Lower End Cap - 225, 225 EFI, 3 Litre

MARINER AND MERCURY

1994 and 1995

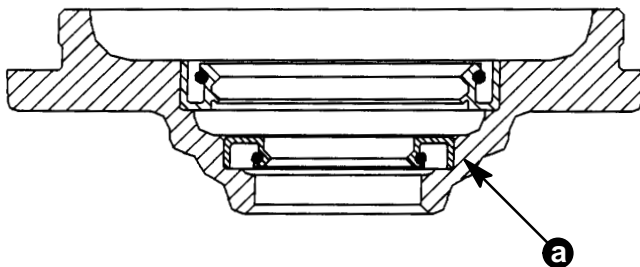
Figure 1. Previous 1171-9787A-1 End Cap Assembly

a. One Drive Shaft Seal

Any time a powerhead with the previous single drive shaft seal end cap assembly is removed, replace the end cap with the new two seal assembly. Stamp the powerhead with two punch marks (figure 3) to identify the installation of the new lower end cap assembly.

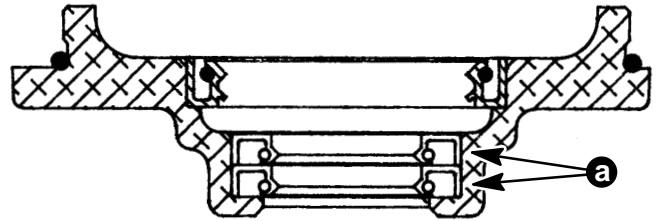
Figure 2. New 1171-9787A-3 End Cap Assembly

Beginning with s/n 0G259668, the 225 carburetor, 225 EFI, and 3 litre Marathon/Sea Pro models have an improved lower end cap installed on the powerhead. The new end cap has a taller casting, 1171-9787-C1 cast on it, and two drive shaft seals instead of one.

a. Two Drive Shaft Seals

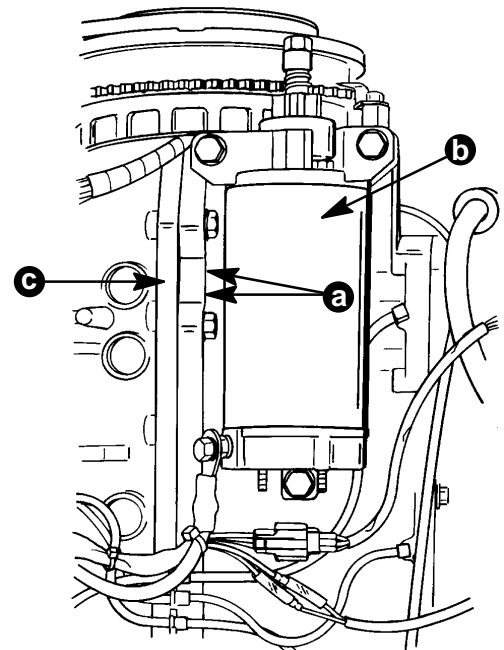
Figure 3. Starboard Side View

A Quicksilver replacement powerhead with the new end cap has two punch marks on the starboard side of the powerhead and/or a date code of X 065 95 and above stamped on the block.

a. Two (2) Punch Marks
b. Starter Motor
c. Date Code

IMPORTANT: Stamp the powerhead with two punch marks for future identification of the installation of the new end cap assembly. Refer to Figure 3.

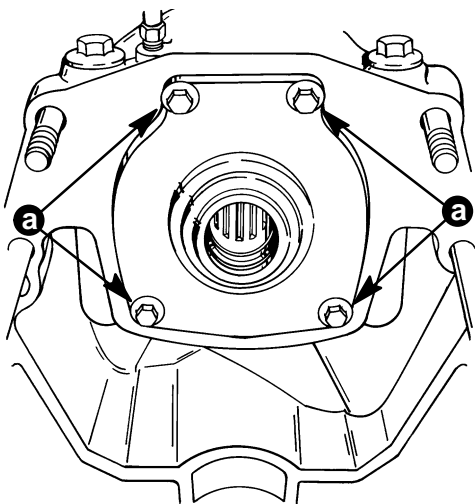
Figure 4. Lower End Cap Removal

a. Attaching Bolts

Remove the lower end cap assembly from the powerhead. It may be necessary to lightly tap the end cap to loosen.

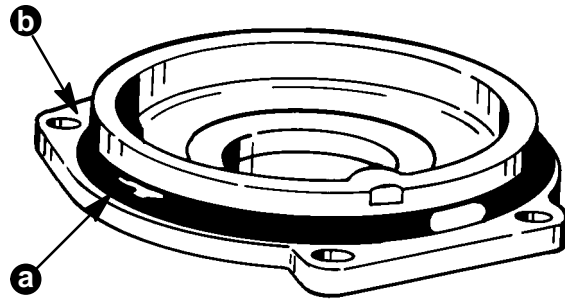
Figure 5. Lower End Cap

a. O-Ring
b. End Cap Flange

Apply a light coat of Perfect Seal (92-34227--1) to the end cap flange.

Lubricate the O-ring seal with Quicksilver 2-4-C with Teflon (92-825407A12) to aid in installation and reinstall the lower end cap assembly.

Assemble the end cap to the powerhead, reinstall the four (4) attaching bolts, and torque to 85 lb. in. (9.6 N·m).
