## Mechanics Precautions - 225, 225 EFI, 250 EFI, 3 Litre Marathon/Sea Pro

#### MARINER AND MERCURY

1994 thru 1996

225, 225 EFI, 250 EFI, 3 Litre Marathon/Sea Pro

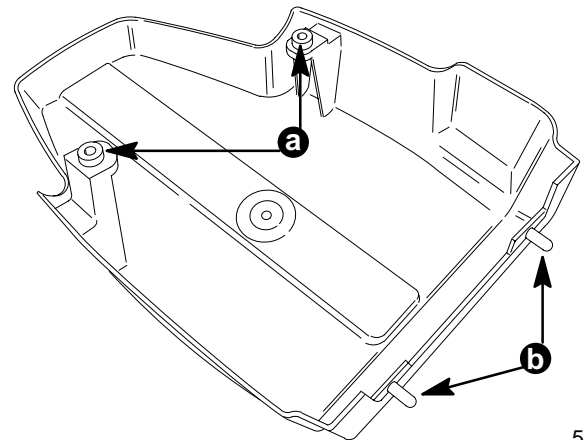
**Figure 1. Flywheel Cover - Carb. Models**

There have been reports of various engine parts being ingested into the intake system on the 3 litre outboards. Some of these parts have lodged in the intake system and have prevented the throttle shutters from closing on both carbureted and EFI models. Throttle shutters stuck open at high engine speed could prevent the engine from being shifted into neutral.

- a - Grommets (2)
- b - Front Location Pegs

Assure that all the grommets, Figures 1 thru 3, are properly installed and seated in the hole both before and after assembly of the covers. As an added precaution, use an epoxy glue or a contact/rubber cement to secure grommets that have become dislodged. Apply silicone grease, silicone spray, or rubber lubricant to the location pegs to aid in installation and removal.

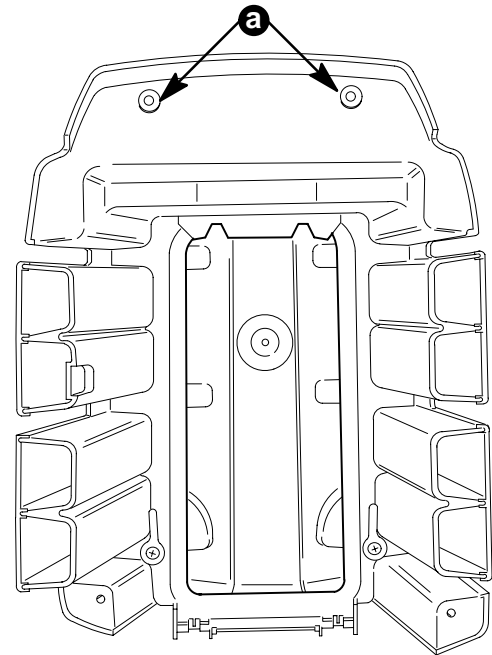
**Figure 2. Air Box Cover - Carb. Models**

- a - Grommets (2)

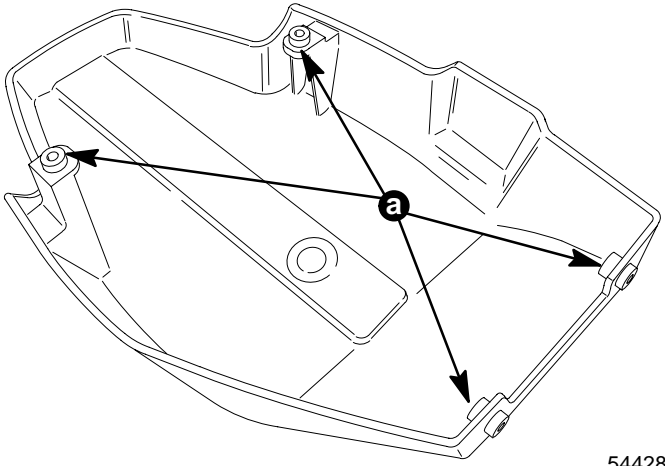
**Figure 3. Flywheel Cover EFI Models**

a - Grommets (4)

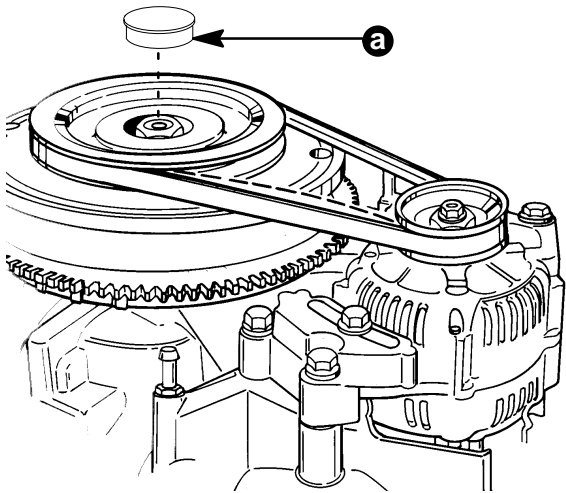
**Figure 4. Flywheel and Stator**

a - Flywheel Plug

Assure that the flywheel plug is properly seated in the flywheel.

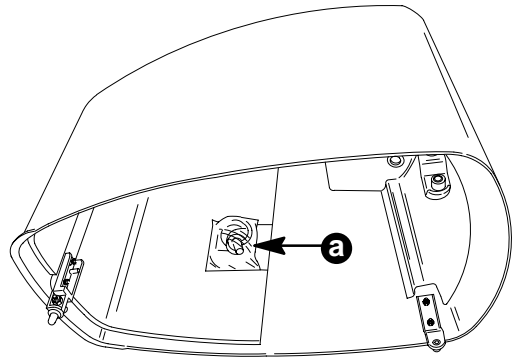
**Figure 5. Inside Starboard Side of Top Cowl**

a - Starter Rope Location

Assure that the starter rope is secured to the inside of the cowl. As an added precaution, remove the starter rope from the bag located on the inside the top cowl and place it with the Operation and Maintenance Manual in the boat.
