Shift Shaft Seal – 225 & 250

Models Affected

MARINER AND MERCURY

1996 225, 225 EFI, 250 EFI

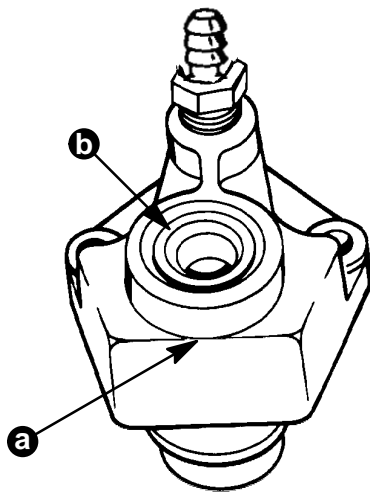
Figure 1. Shift Shaft Bushing Assembly

The shift shaft oil seal on the models listed may become loose and allow water to enter the gearcase. On a small quantity of units, the shift shaft oil seal hole in the bushing was machined 0.002 inch (0.05 mm) too large.

When servicing any of the product listed, check if the powerhead has the identification mark and, if not, replace the shift shaft bushing and mark the powerhead.

When replacing a shift shaft bushing on 225, 250, and 3 Litre Marathon/Sea Pro models, install p/n 23-815921A 4. The A 4 has a p/n 23-816464 1 shift shaft seal that will release excess pressure. The parts manual will be changed at the next reprint.

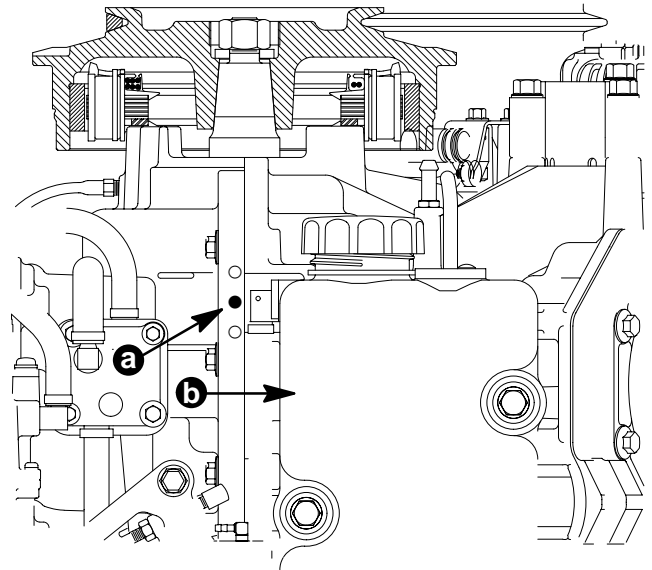
Figure 2. Port Side View

a white paint dot on the port side of the powerhead by the crankcase split line forward of the top of the oil tank.

Paint a white paint dot on the port side of the powerhead by the crankcase split line forward of the top of the oil tank (refer to Figure 2).
