Reverse Gate Adjustment - Sport Jet 175 XR²

All Sport Jet 175 XR² Models

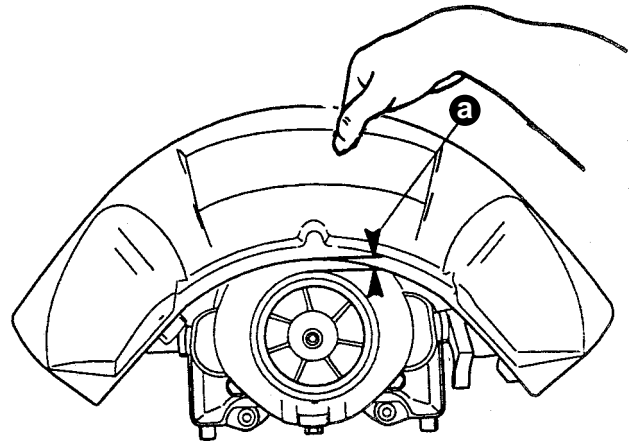
a - 3/8" (9.5 mm) to 1/2" (12.7 mm)

We have received reports from the field of failed reverse gate stops. Review of these failures indicate the cause was due to improper adjustment of the shift cable. If the lower edge of the reverse gate is not 3/8" (9.5 mm) to 1/2" (12.7 mm) above the edge of the steering rudder after removing the shift cable slack in the forward position, damage to the stops and reverse gate may occur.

To check shift cable adjustment, first shift the remote control lever into the forward position. Apply a light downward pressure on the reverse gate until all slack is removed from the shift cable. While maintaining the downward pressure to remove the cable slack, measure the distance between the lower edge of the reverse gate and the upper-most portion of the steering rudder (dimension "a" in figure below). This dimension should be between 3/8" (9.5 mm) to 1/2" (12.7 mm). If the clearance is less than 3/8" (9.5 mm), readjust the shift cable as outlined in the installation manual (P/N 90-10164970) or the service manual (P/N 90-852396).
