# service bulletin

No. 98-7

## Propeller Failures and Guidelines – 6 thru 250

MERCURY/MARINER  
6 thru 250

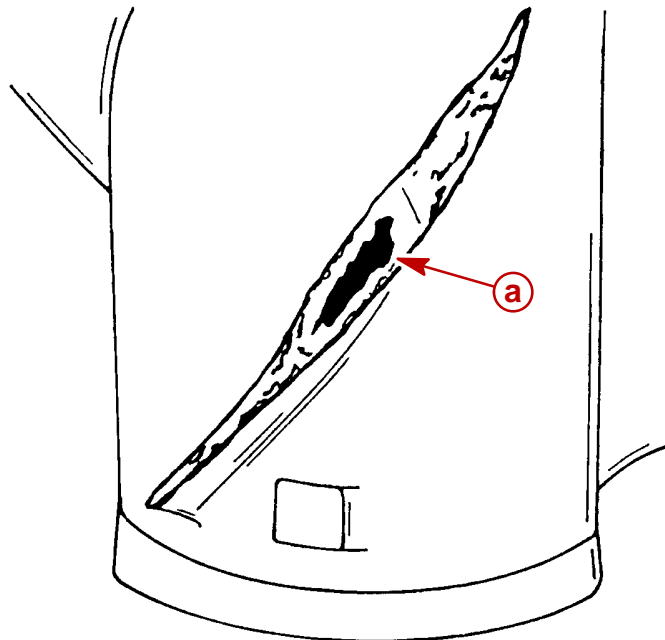
The illustration below shows a propeller with loss of blade. This failure is a result of a casting void (a). This represents a true defect in material.

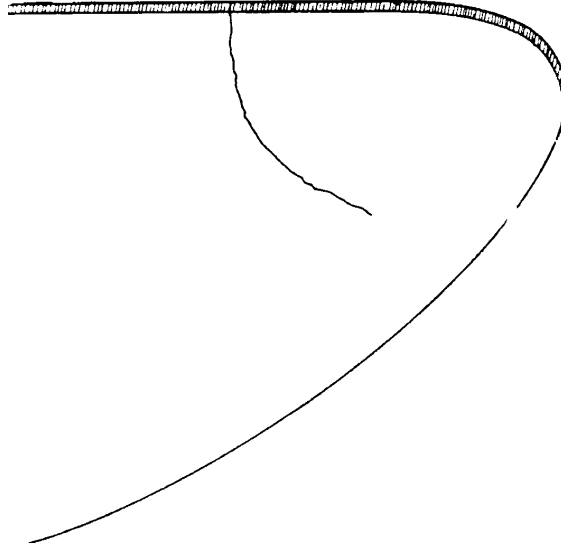
The illustration below shows a propeller blade with a blade failure. This failure is on the trailing edge and is a result of a fatigue crack. This type of fatigue failure starts at the trailing edge of the propeller blade and works its way to the leading edge. This type of failure can be caused by cup modifications, improper repairs, impacts, and blade flex. Blade flex is the only possible warrantable condition among the previously listed causes. Failure caused by cup modifications, improper repairs, or impacts are not covered by MMPC's limited warranty.

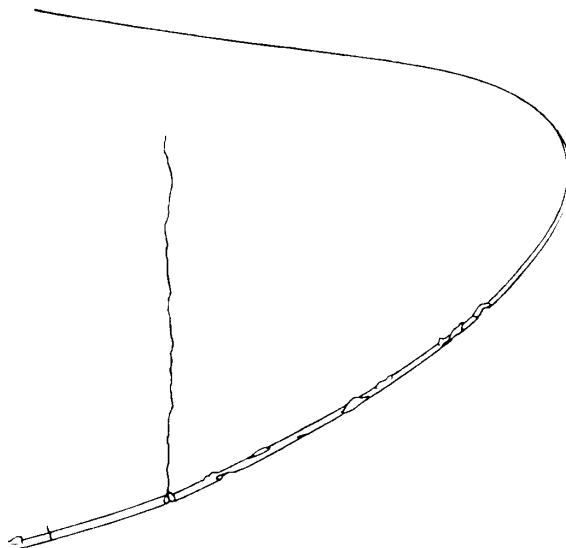
The illustration below shows a propeller with a fracture line starting at the leading edge of the blade. Leading edge fatigue cracks are caused by impacts with objects in the water, often not even detected or observed by the boat operator. Small nicks on the leading edge, if left undressed, can cause fatigue cracks. Instructions for dressing small nicks on the leading edge are found in the MMPC Propeller Guidebook. Fatigue cracks starting on the leading edge are not covered by MMPC's limited warranty. The owner may wish to report this type of fatigue failure to a casualty insurer, as they are impact failures.
