## Burned Propeller Hubs and Shaft Seals 3.0 Litre

### Models Affected

MERCURY/MARINER  
1997 AND 1998, 225/250 HP, 3.0 LITRE  
S/N 0G438000 Thru S/N 0G693841

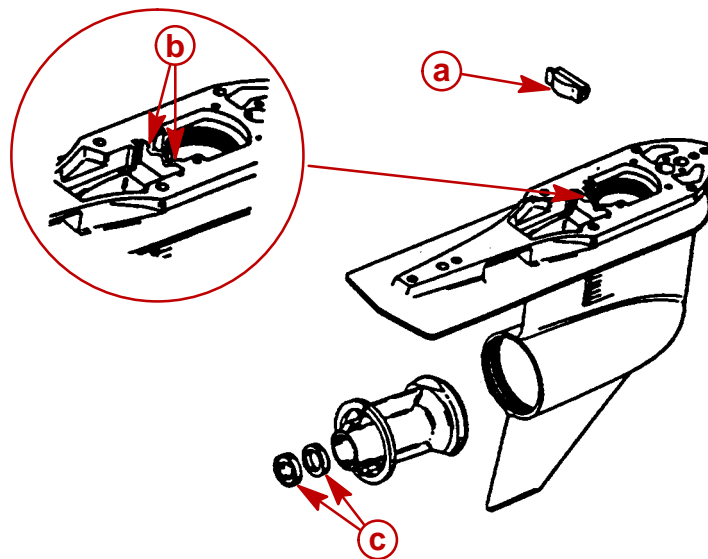
Some 3.0 Litre outboards have experienced low hour failures of burned propeller shaft seals, propeller hubs, gear case rubber filler blocks, and accelerated corrosion of the gear case, caused by unusually hot exhaust. These problems generally result from a lack of cooling water to the gear case caused by the following items.

- Outboard mounted too high
- Outboard operated too high on a jack-plate
- Outboard trimmed too far out for boat application
- Cooling water being air-ventilated, or deflected by the hull, or attachments to the hull

- a** - Filler Block
- b** - Corroded Exhaust Dam
- c** - Propeller Shaft Seals

Install High Speed Pick-up Plates P/N 17280A2 on outboards between serial numbers 0G438000 and 0G693841 and assure that the outboard is properly mounted as follows.

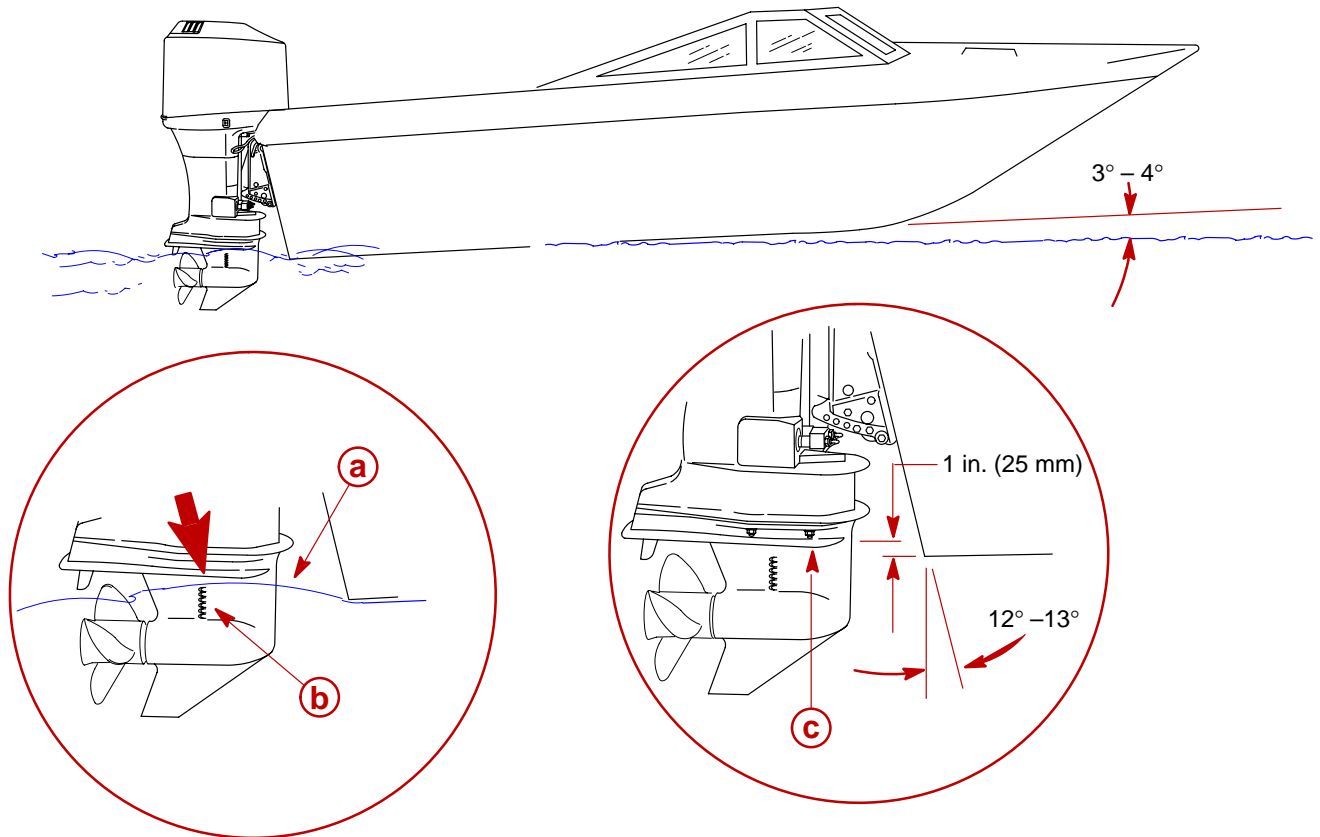
**Example # 1** Boat with 12-13 degree transom angle (typical of most boats) provides good bow lift when outboard is trimmed out and a top speed in the low 50 MPH (80 km/h) range. With this combination, the anti-ventilation plate runs parallel to the water line and can be mounted 1 in. (25 mm) above the boat bottom.

- a** - Water Line
- b** - Cooling Water Inlets
- c** - Anti-Ventilation Plate

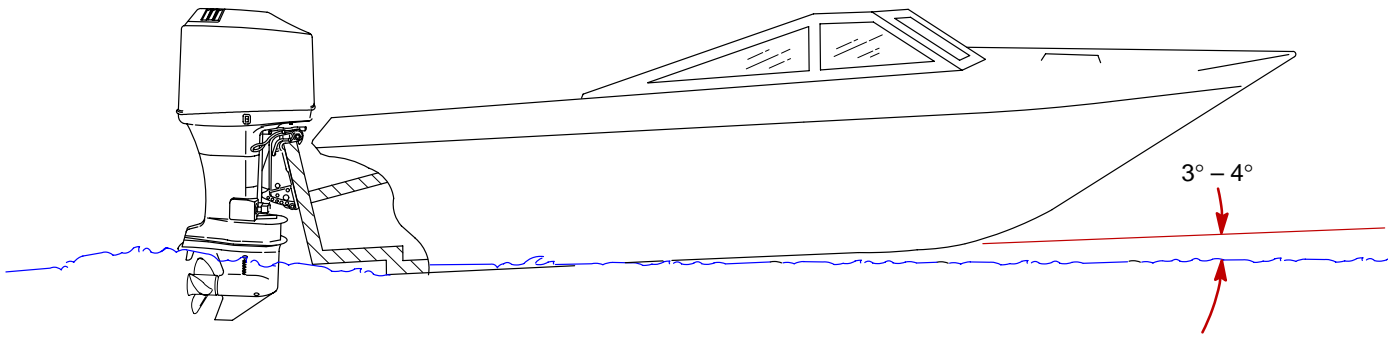
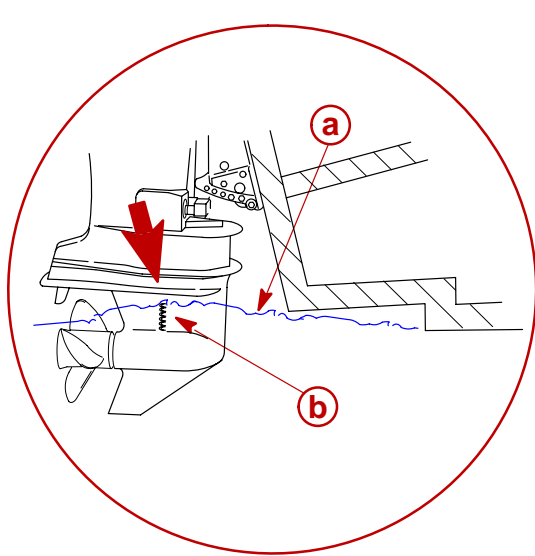
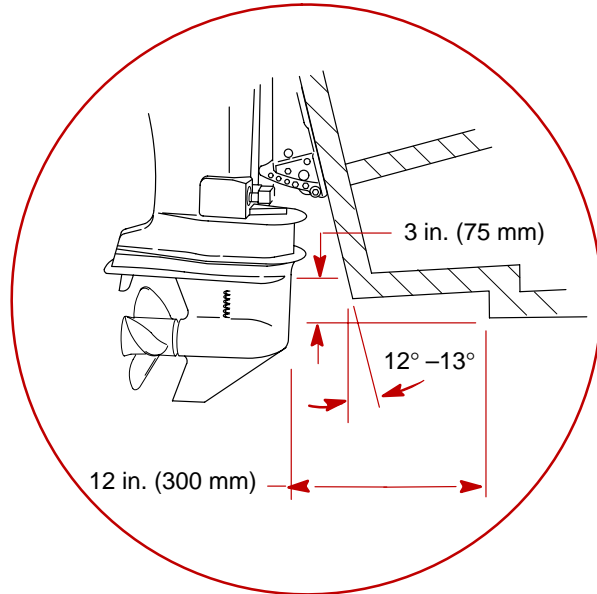
**Example # 2** Boat with notched transom provides good bow lift and is capable of running in the low 60 MPH (97 km/h) range. Boat speed, along with the notched transom, allows the engine to be mounted with the anti-ventilation plate 3 in. (75 mm) above the boat bottom.

- a** - Water Line
- b** - Cooling Water Inlets

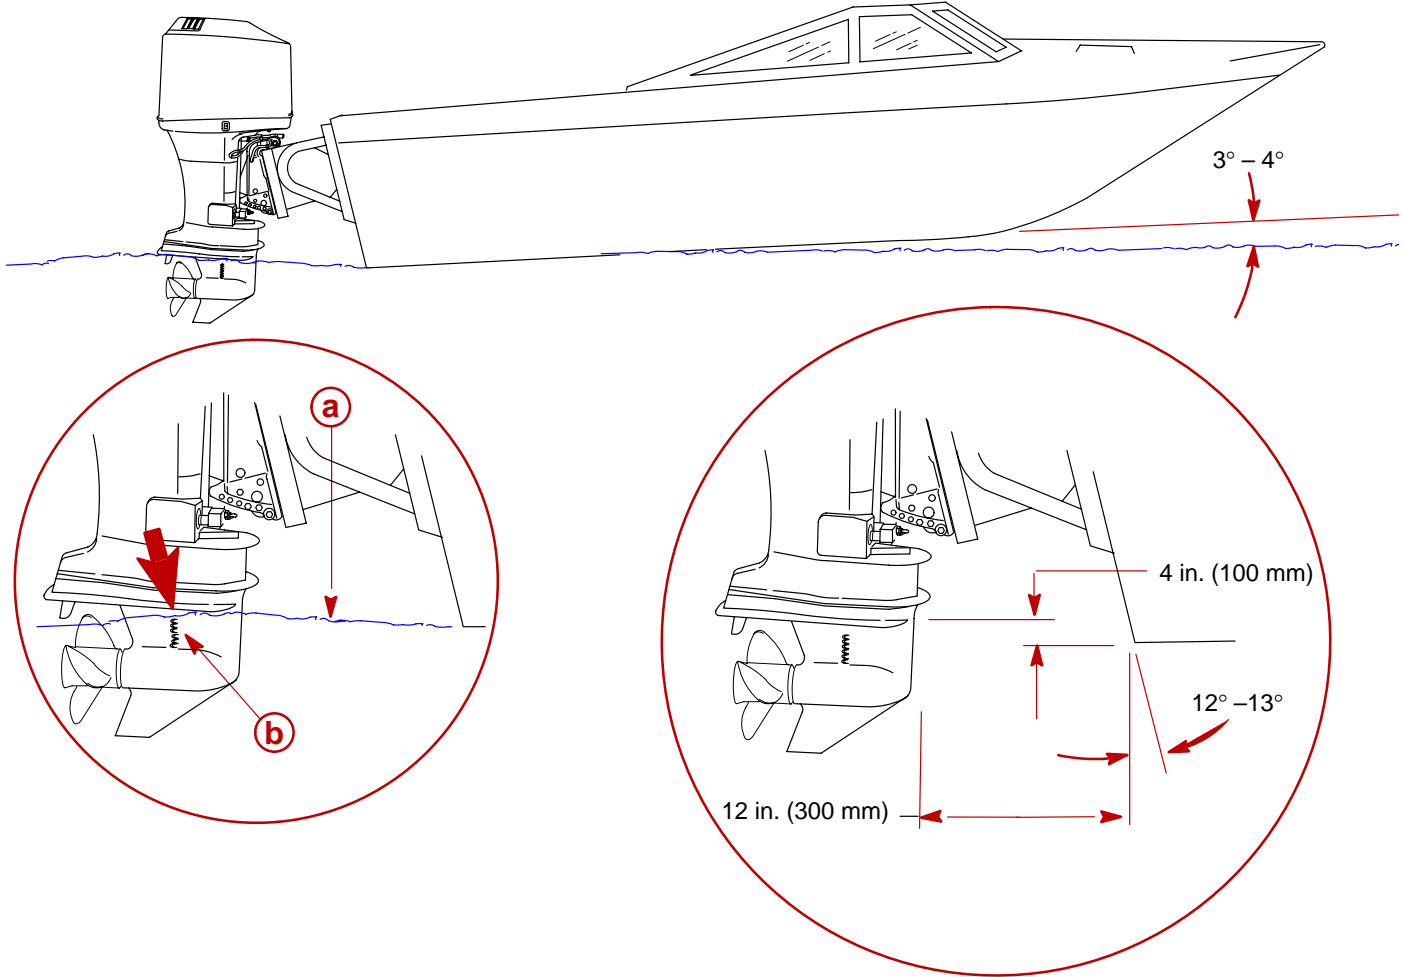
**Example # 3** Boat using 12 in. (300 mm) set back plate, provides good bow lift and a top boat speed in the mid 70 MPH (113 km/h) range. In this application the boat speed allows us to raise the engine 3 in. (75 mm). The 12 in. (300 mm) set back plate gives us another 1 additional in. (25 mm) for a total of 4 in. (100 mm) above standard height.

- a** - Water Line
- b** - Cooling Water Inlets

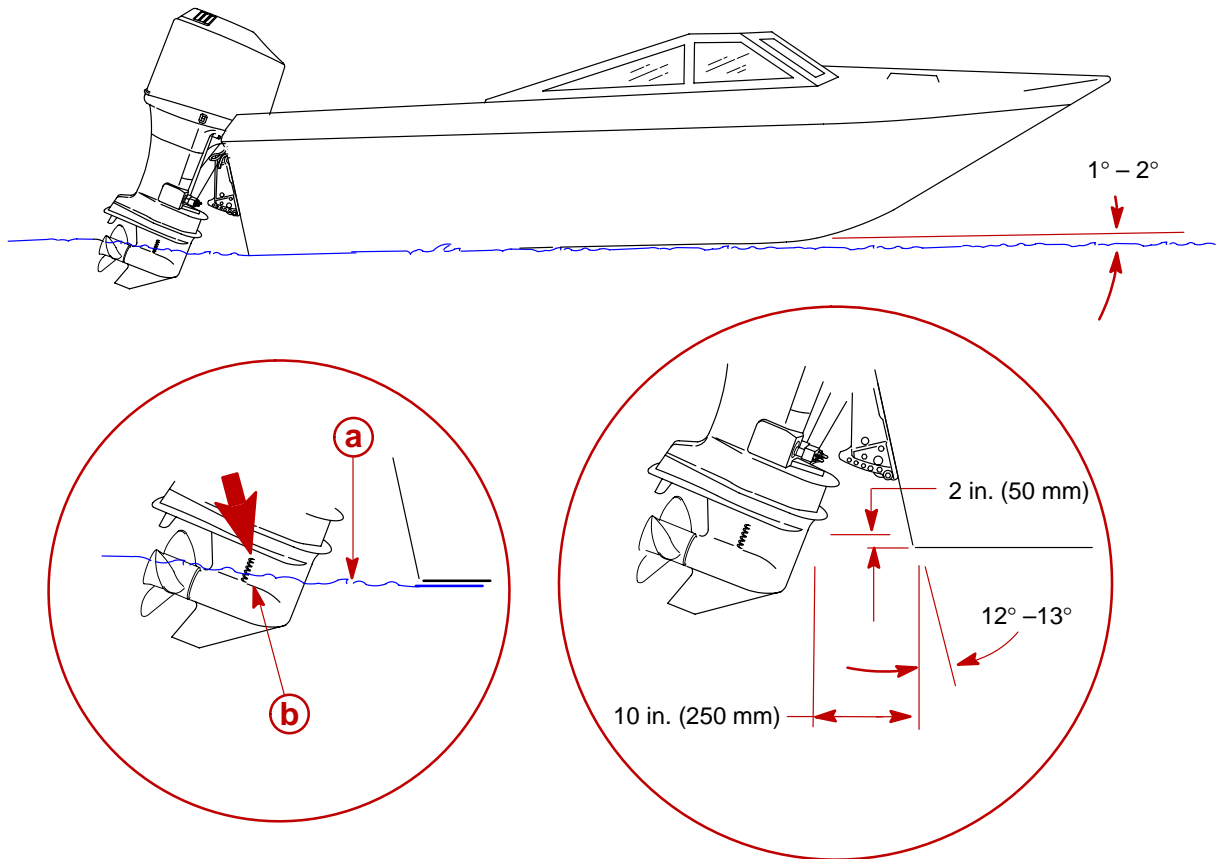
**Example # 4** Boat with poor bow lift, in the full trim position, will allow the anti-ventilation plate to be above and at an angle to the water line. The upper water inlets are likely to draw in air causing overheating of the power head and/or exhaust system. Options would be to lower the engine, add high speed pick-up plates, limit the use of the power trim, or where possible move weight in the boat further aft (moving boat center of gravity further aft) to aid bow lift.

- a** - Water Line
- b** - Cooling Water Inlets

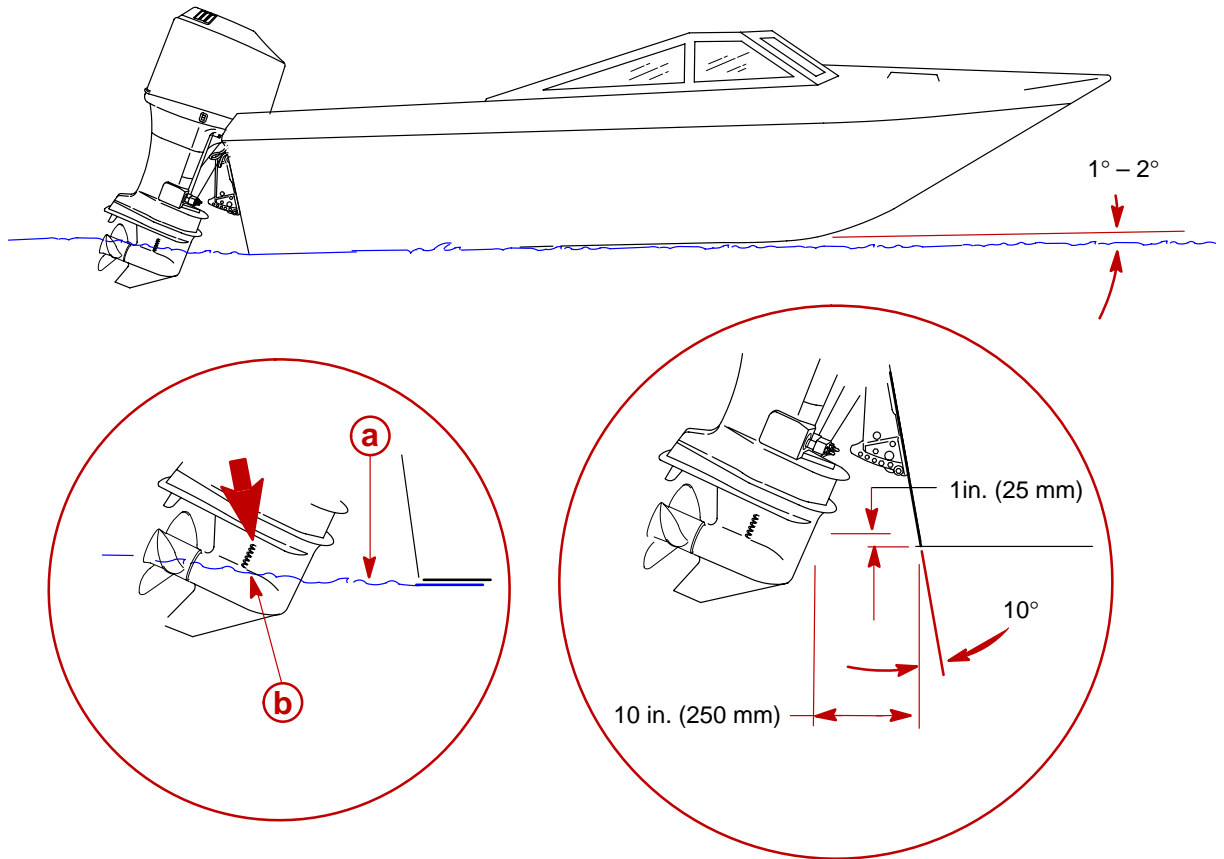
**Example # 5** Boat has a top speed in the low 50 MPH (80 km/h) range, with poor bow lift and low transom angle. Due to the low transom angle, and poor bow lift, when the engine is fully trimmed out, the anti-ventilation plate is running above and at an extreme angle to the water line. The water inlet holes are almost completely out of the water. On this type of boat, even with the engine mounted all the way down on the transom, the engine may not receive adequate cooling. Options would be to install the high speed pick-up plates, limit the use of the trim, or where possible move weight in the boat further aft (moving boat center of gravity further aft) to aid bow lift.

- a** - Water Line
- b** - Cooling Water Inlets

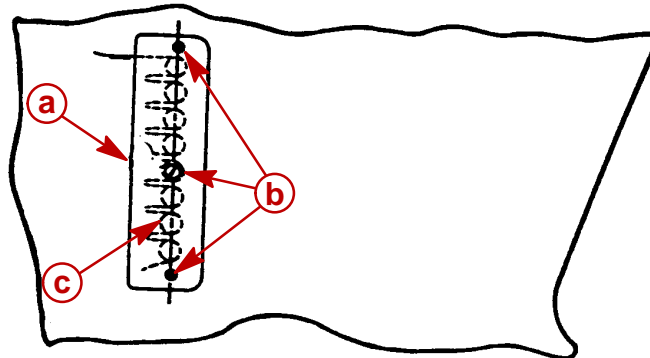
**NOTE:** The high speed pick-up plates have greater possibility of blockage from under water debris.

- a** - High speed pick-up plate P/N 17280A2
- b** - Mounting bolts (3)
- c** - Water inlet holes (8) each side

Installation of high speed pick-up plates may increase water flow and help cooling of the engines exhaust system and power head.
