## 135/150 Optimax Update

### Models Affected

#### MERCURY/MARINER

S/N 0G636539 Thru S/N 0G692839

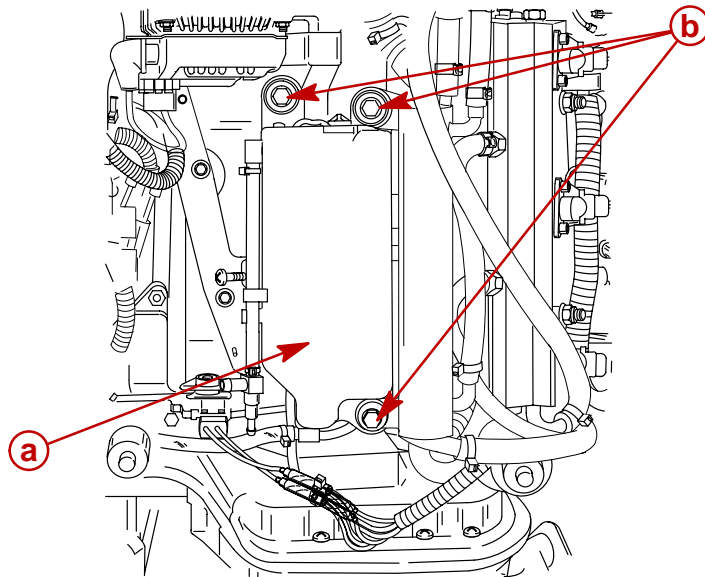
#### ITEM # 1 ENGINE OIL RESERVOIR – S/N 0G636539 THRU S/N 0G637527

Replace engine oil reservoir to avoid false low oil signals. The replacement engine oil reservoir sensor switch and float, are less sensitive to alternator magnetic field interference. New reservoir P/N 833069A3 includes new sensor and float assembly.

a - Engine Reservoir

b - Bolts (3) [Torque to 170 lb. in. (19.2 N·m)]

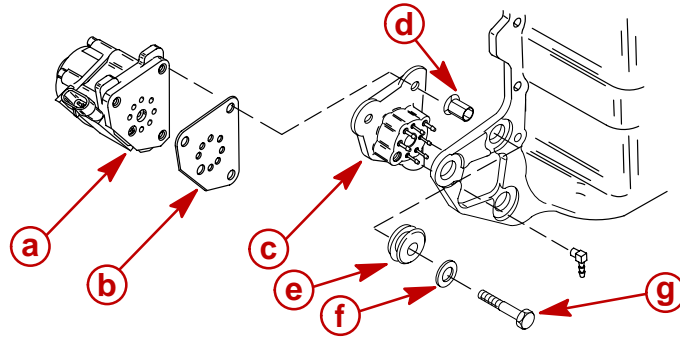
**ITEM # 2 OIL PUMP GASKET – S/N 0G636539 THRU 0G654821**

Replace gasket between the oil pump and oil pump bracket. New gasket P/N 27-856542 1 has improved sealing capabilities. New gasket is included in service kit P/N 802707A2.

- a - Oil Pump
- b - Gasket
- c - Bracket
- d - Bushing (3)
- e - Rubber Grommet (3) – Insert into Hole
- f - Washer (3)
- g - Bolt (3) – Torque to 16 lb. ft. (22.0 N·m)

**NOTE:** When oil reservoir, oil pump gasket, or oil hoses are changed, the oil pump priming procedure must be performed. Refer to section 3C-4 of the 135/150 Direct Fuel Injection Service Manual (P/N 90-855347) for correct procedure.

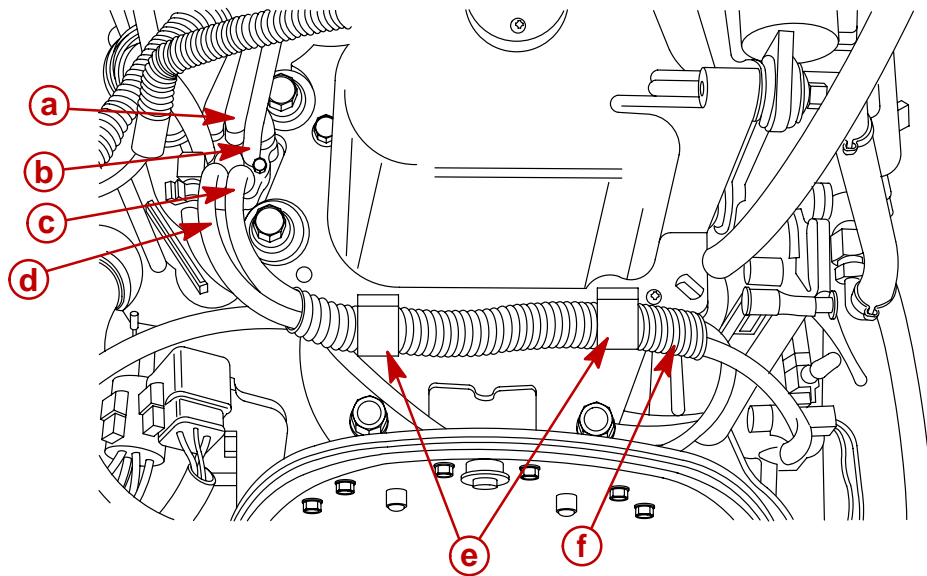
**ITEM # 3 OIL HOSES – S/N 0G636539 THRU 0G692839**

Replace the four smaller diameter oil hoses that supply oil to the port side cylinders, and air compressor. New hoses are made of an improved material. Four 28-1/2 in. hoses will be supplied in the kit, three must be cut to length. Route hoses as shown below, using conduit and clamps supplied with kit P/N 802707A2.

- a - Oil Hose Air Compressor
- b - # 2 Cylinder
- c - # 4 Cylinder
- d - # 6 Cylinder
- e - New "J" Clamps, Torque Clamp Retainer Bolts to 100 lb. in. (12.0 N·m)
- f - Conduit Supplied with Kit

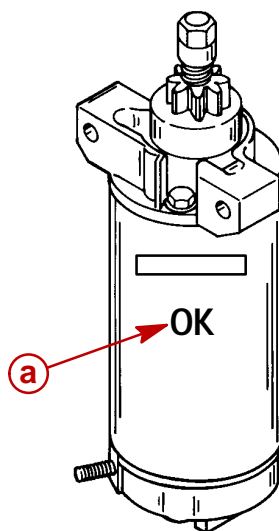
**ITEM # 4 STARTER MOTOR – S/N 0G636539 THRU 0G638551**

The rubber snubber inside the motor housing may have been, dislodged during assembly. Inspect engine carton, or starter motor for having been reworked at the factory. Rework identification listed below. If engine has **NOT** been reworked at the factory, replace the starter motor with **P/N 50-833153 2**.

a - Factory rework marking (OK)

**FACTORY REWORK:** Engines reworked at the factory will have a Blue dot marked on the engine carton near the serial number location, and the white letters "OK" marked on the starter motor near the part number label.

**DEALER REWORK:** Mark the replacement starter motor with the white letters "OK" near the part number label.

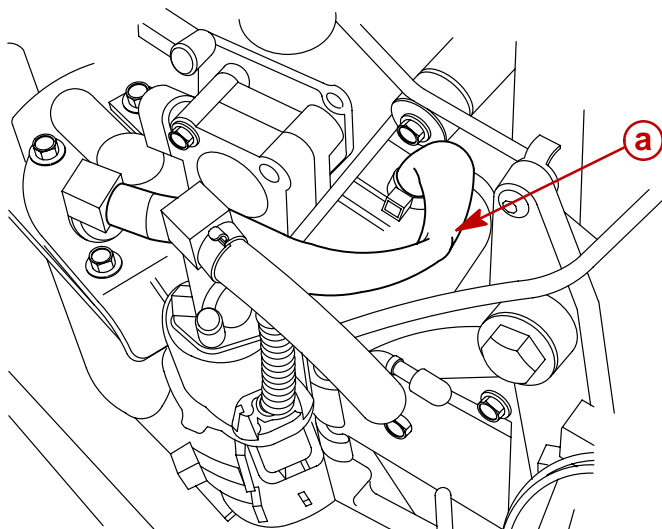
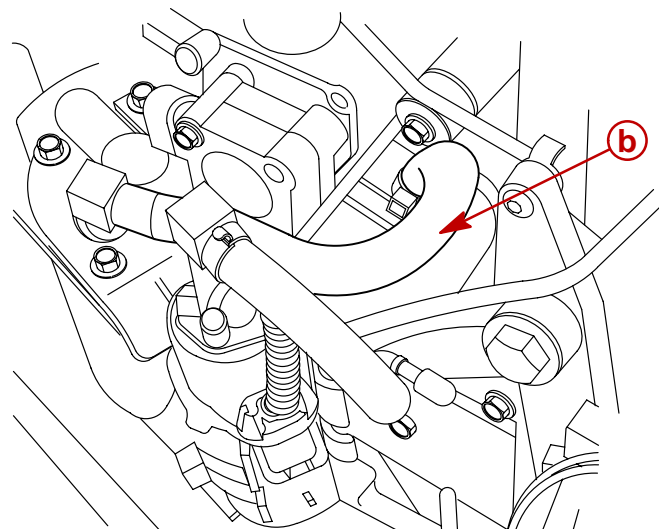
**ITEM # 5 FUEL HOSE – S/N 0G636539 THRU 0G666068**

The pulse fuel pump hose to the vapor separator tank (VST) could have a partial kink at the formed bend. Inspect hose and shorten at the VST end to remove kink. The amount of hose removed may vary between 3/8 in. to 1/2 in.

a - Fuel hose with kink  
b - Fuel hose with correct contour (no kink)

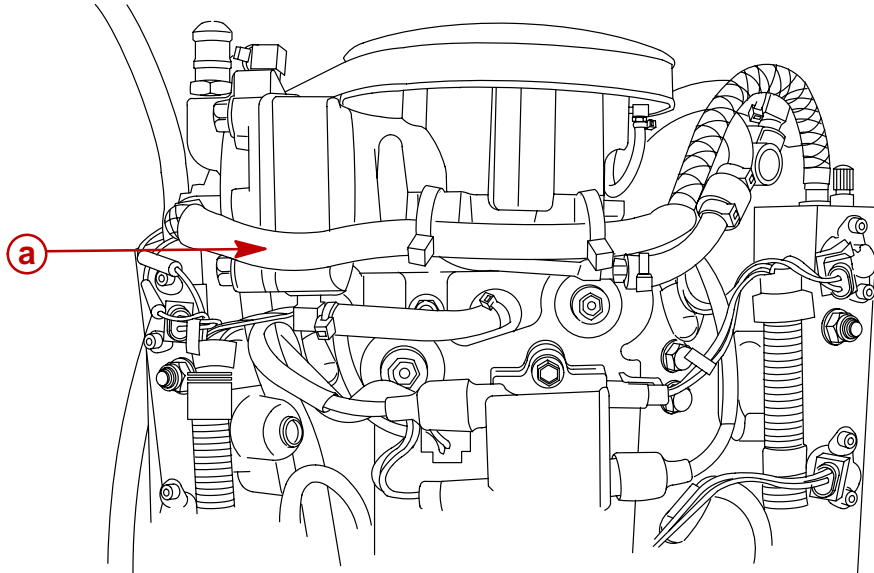
**Rear View Of Power Head**

Replace the air compressor output hose. This new formed hose has improved alignment with the fitting on compressor and fuel rail. Engines that have been reworked at the factory, have a GREEN dot marked on the engine carton near the serial number.

a - Air pressure hose

New air pressure hose P/N 32-850251 1 and metal clamps are included in kit P/N 802707A2.

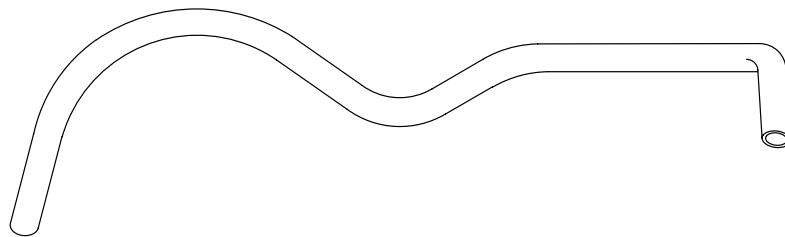
**ITEM # 6 AIR PRESSURE HOSE – S/N 0G636539 THRU 0G665930**

**Old Air Hose Contour**

**New Air Hose Contour**

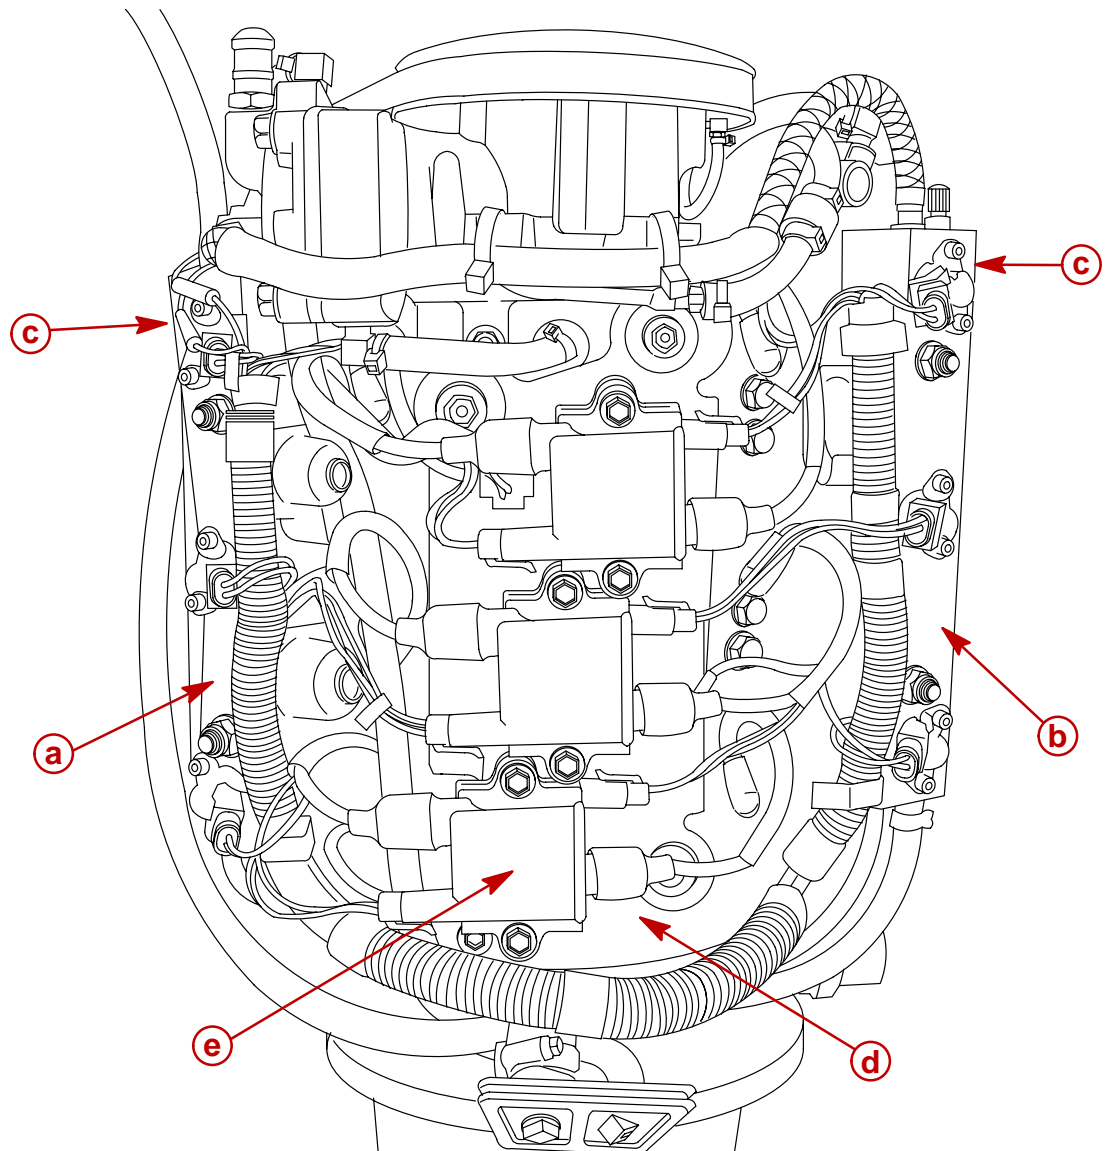
**ITEM # 7 FUEL RAIL PART NUMBER LABEL – S/N 0G670200 THRU S/N 0G681161**

The fuel rails are identified with part number labels. The starboard fuel rail between serial numbers listed above may have incorrect labels. Part number labels on engine components should not be used when ordering part. To eliminate any confusion, check for the correct part number label on the starboard fuel rail. If the label is incorrect, remove and discard, replacement label is not required.

**Incorrect part number**      **852378A4**  
**Correct part number**        **852379A4**

- a - Port fuel rail
- b - Starboard fuel rail
- c - Label location
- d - Ignition coil plate assembly mounting bolts (4) torque 235 in. lbs. (27.0 N·m)
- e - Ignition coils (stacked in pairs)

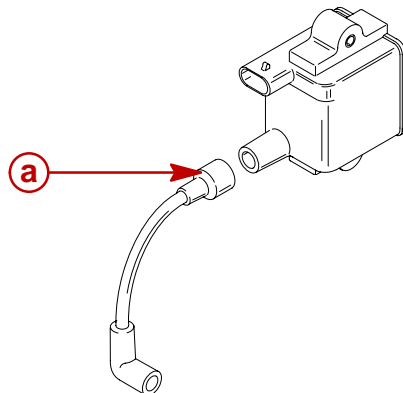
**ITEM # 8 SPARK PLUG BOOTS – S/N 0G636539 THRU S/N 0G681161**

The boot on the ignition coil high voltage tower may become loose, allowing contaminants to enter. Ignition coils now have the boot glued in place to prevent loosening. Because of the difficulty in cleaning the existing boots and coil towers, to insure good bonding of parts, replace the complete ignition coil plate assembly. For this up-date only order one ignition plate P/N 850675A3 for each outboard. Ignition plate assembly will include all coils, and Hi-tension leads, pre assembled and ready to install.

a - Coil high voltage tower boot

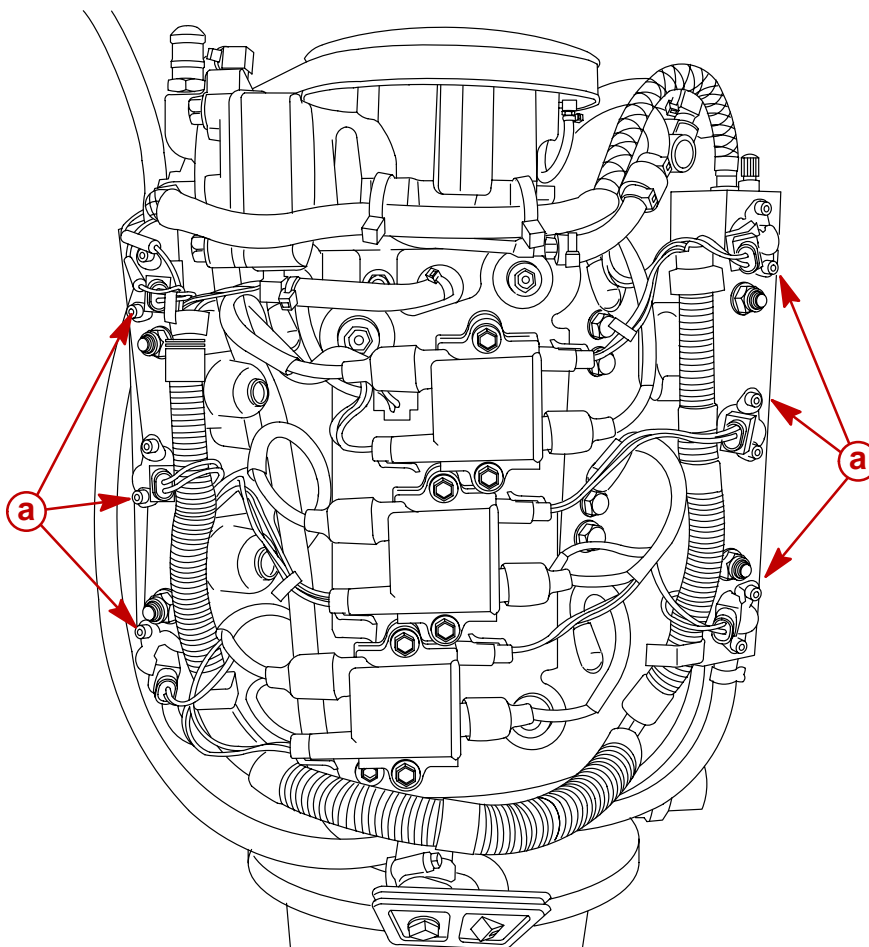
**ITEM # 9 FUEL INJECTOR RETAINER BOLTS – S/N 0G680738 THRU S/N 0G693228**

The fuel injector retainer bolts may have been torqued incorrectly. Check the torque of the 12 bolts that retain the 6 fuel injectors. Torque should be 55 in. lbs. (6.2 N·m).

a - Fuel Injector Retainer Bolts (12) – Torque to 55 lb. in. (6.2 N·m)

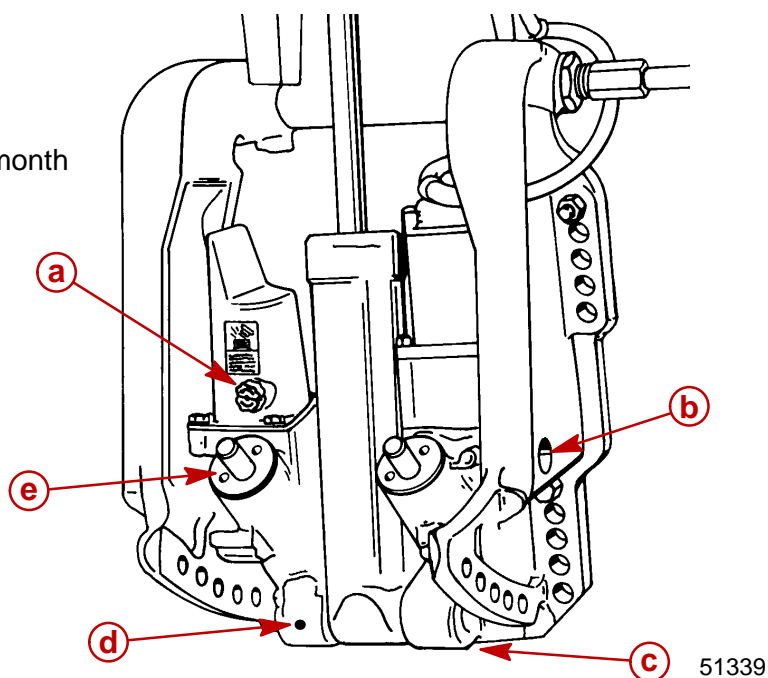
**ITEM # 10 POWER TRIM PISTON/ROD – S/N 0G653854 THRU 0G681265**

The port side power trim piston/rod assembly may have been incorrectly machined on some of the engines listed. This could cause the tilt relief valve function to become disabled, allowing the engine to trim past the clamp brackets at higher than normal propeller thrust.

- A white paint dot on the port side of the trim manifold near the tilt cylinder lower cross pin area.
- Engine carton will have a **ORANGE** dot near the serial number location.

Any engine that **DOES NOT** have the factory rework marking, should have the anode assembly removed from the power trim, to inspect for affected date codes. Affected date codes are 7I02 thru 7K07. Power trims with date codes that are not in the affected range do not require trim piston/rod replacement.

- a - Fill cap  
 b - Manual valve  
 c - Date code location  
 d - Factory rework mark (white dot)  
 e - Port trim ram

1. Tilt outboard to the full "UP" position and engage tilt lock lever.
2. Slowly remove "Fill" plug, and turn manual release valve 3 to 4 turns (counterclockwise) to bleed pressure.

3. Place a clean pan under trim system to catch fluid.
4. Loosen the port side trim rod cylinder cap using spanner wrench (91-74951), or cap removal tool (91-44487A1). Before removing, clean any dirt or loose paint chips from around cap area.

5. Remove trim rod cylinder cap.
6. Install trim rod removal tool (91-44486A1) and pull trim piston/rod assembly from cylinder.
7. Install cylinder cap over new piston/rod assembly.

8. Apply Quicksilver Power Trim and Steering Fluid on all O-rings and seals before installation.
9. Install trim rod and cap.
10. Tighten cap securely.
11. Close the manual tilt valve and reservoir cap.

12. Disengage the tilt lock lever.
13. Cycle the trim system 2 times (full tilt to full retract) and recheck fluid level.

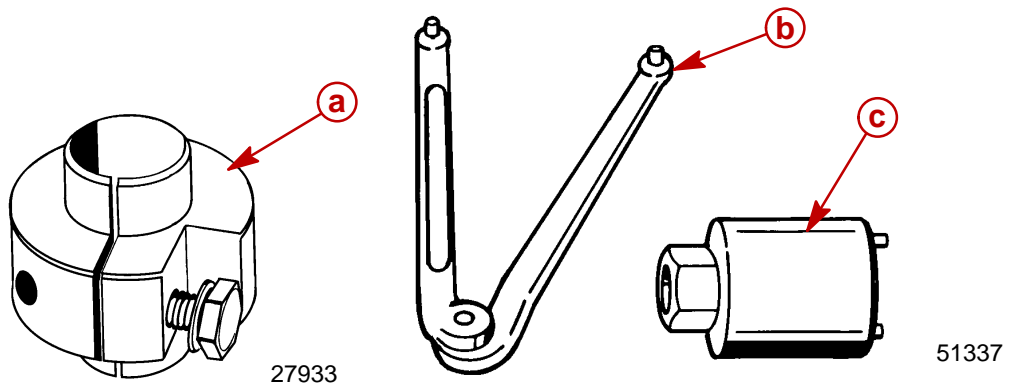
- a - Trim rod removal tool (91-44486A1)  
 b - Spanner Wrench (91-74951)  
 c - Cap removal tool (91-44487A1)
