Service Bulletin

Bulletin No. 2006-18

SportJet 200 HP OptiMax Fuel Lift Pump (Electric)

Models Covered	ered Serial Number Or Year	
Mercury SportJet 200 HP OptiMax	S/N 0E432496 to 0E433492

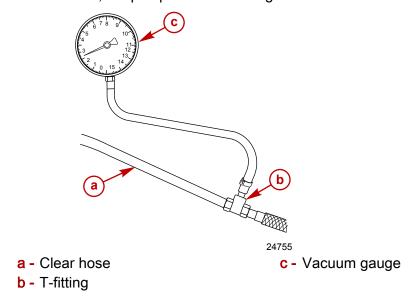
Before proceeding with the system vacuum test, confirm that the fuel lift pump is capable of supplying the required vacuum. To do this, start the engine and pinch off/restrict the fuel supply hose between the vacuum gauge and fuel tank. The vacuum gauge should rise to or exceed the maximum normal reading of 2.5 inches vacuum (mercury). If it fails to reach this minimum number, the pump needs servicing.

If the lift pump fails the previous test, replace the 2.5L lift pump (P/N 880001A03) with the 3.0L lift pump (P/N 885555T03.)
