Service Bulletin

Bulletin No. 2006-13
OEM No. 2006-09

Official Recall Notification Federal Boat Safety Act Commander 3000 Remote Control

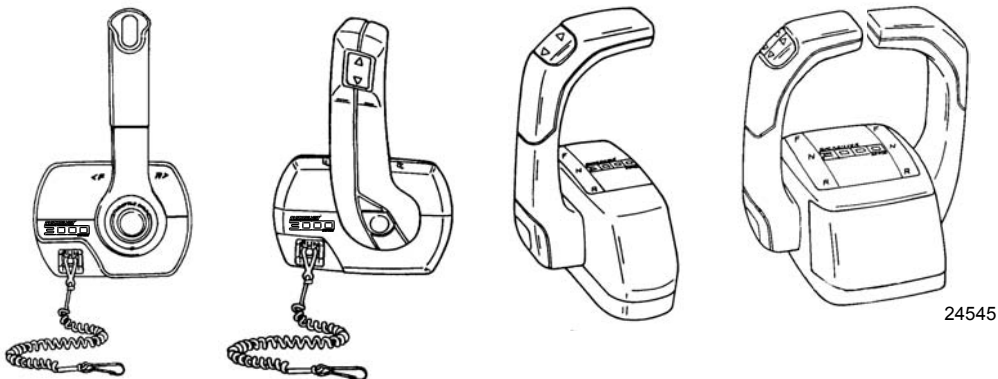
1. **Determine if you have a Commander 3000 control.** If the control in your boat does not match any of the controls pictured below, you do not have a Commander 3000 Control and this recall does not apply to you.

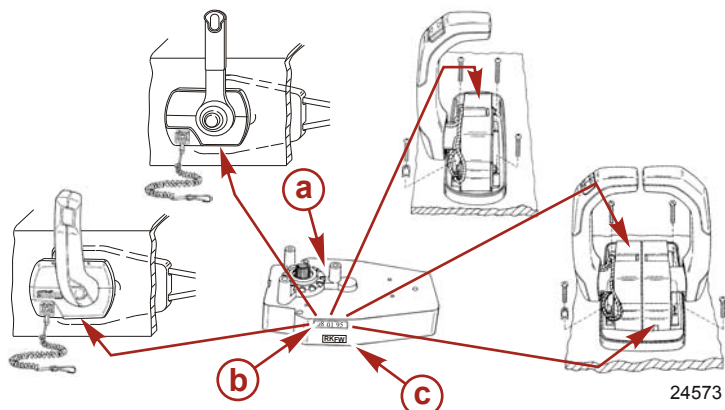
IMPORTANT: You are affected by this recall, and the control mechanism must be replaced, if it was built between June 1, 1994 and September 1, 1995 and does not have a "RKFV" decal on it.

a - Control Mechanism
b - Build Date Decal

c - RKFV Decal

NOTE: The date may appear on the control in different forms: 08/01/95 (month/day/year) August 1, 1995. The month may also be written out in alpha characters as in the following: Aug/1/95 or 1/Aug/95. Decals may be placed in other locations.

The mechanism of Commander 3000 remote controls built between June 1, 1994 and September 1, 1995 that do not have the RKFV decal, and those found with no build date must be replaced with a Gen II Remote Control and Gen II Cables as described in tables below. The Gen II Remote Control must be used with Gen II Cables for this replacement as the Gen I Commander 3000 Remote Controls are no longer available (NLA).
