Engine Wiring Harness Chafing – 200/225/250/275 Verado

Models Covered	Serial Number
200/225/250/275 Verado	1B390142 and Below
EU 200/225/250/275 Verado	0P468636 and Below

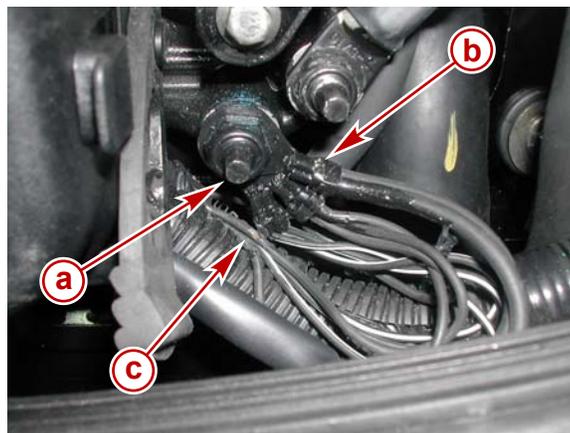
25711

Mercury Marine has identified a potential engine wiring harness chafing issue located on the starboard side of the engine near the lower forward corner of the electrical box. As the ground wire ring terminals are secured with the grounding stud locknut, the terminals can fan out toward the engine wiring harness conduit. Wires protruding out of the conduit slit at this location can become chafed by the wire crimped portion of the ground wire ring terminal and be shorted to ground. Depending on the wires shorted, an engine system failure and/or an engine guardian fault may occur. Mercury Marine has changed the orientation of the described ground wire ring terminals and corrected this issue.

- a** - Ground stud
- b** - Crimped end of ring terminal
- c** - Chafed wire

IMPORTANT: Prior to performing in-depth troubleshooting procedures on these affected outboards, examine the engine wiring harness condition around the ground stud location. Repair any damaged wires or replace the engine wiring harness as required.

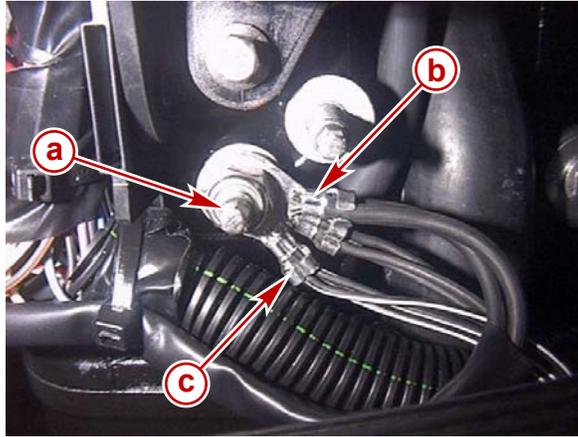
25712

- a - Ground stud/locknut
- b - Ground lead ring terminals
- c - Ring terminal crimp too close to wiring harness

1. Remove the locknut securing the three ground lead ring terminals to the ground stud.

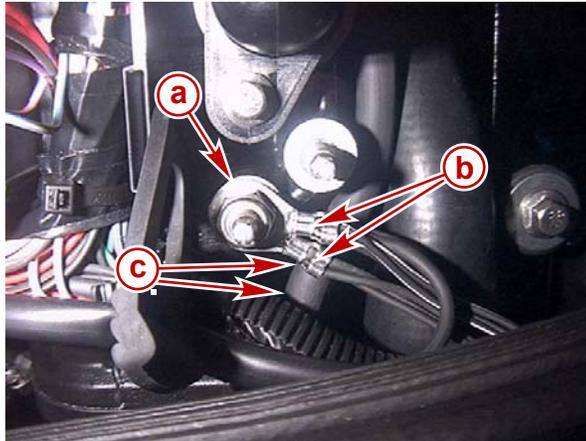
25713

- a** - Heavy terminal - Crimp toward engine (positioned behind outer terminals)
- b** - Two remaining terminals - Crimp away from engine
- c** - Clearance between crimps and harness

2. Clean the neoprene protective coating from the ring terminals, ground stud, locknut, and the contact surface of the cylinder block mounting boss.
3. Reposition the ring terminals:
 - Heavy terminal should be installed first with the crimp toward the engine.
 - Two remaining terminals should be installed with the crimps facing away from the engine.
4. Stack and position the ring terminals to provide clearance from the engine wiring harness. Hold the ground wire terminals in this position and secure the connections with the locknut.

Description	Nm	lb. in.	lb. ft.
Locknut (M8)	17	150

5. Coat the ground wire connection with Liquid Neoprene.
