ADVISORY
 BULLETIN

No. 2000-05

Manual Tilt Cross Pin Loose – 55/60 (2-Stroke)

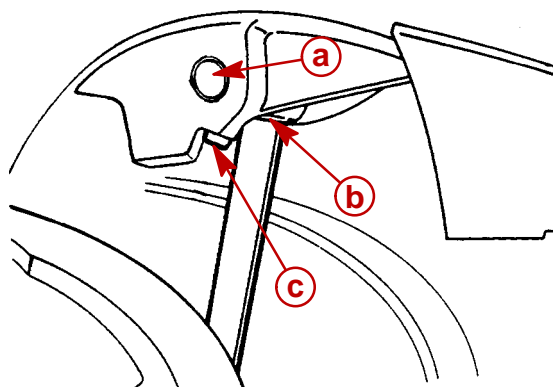
51147

55 and 60 hp three cylinder two stroke outboards within the serial number range listed in this advisory may have an upper manual tilt cross pin that is not properly held in place. The locking tri-lobe pin hole may be drilled off location and has not positioned the locking pin properly in the groove of the cross pin.

If a loose upper manual tilt cross pin moves out of location towards the port side, the pin end may eventually interfere with the port clamp bracket and hinder tilting of the outboard. If the cross pin moves to the starboard side, it could disconnect from the manual tilt rod end and not provide the tilt assist feature as designed.

- a** - Manual Tilt Upper Cross Pin.
- b** - Tilt Rod End.
- c** - Locking Tri-Lobe Pin.

Inspect every outboard listed in this document for a loose manual tilt upper cross pin. If the pin is loose and not retained by the locking tri-lobe pin, install a newly designed Swivel Bracket Pin Assembly P/N 17-878592A1. The pin assembly contains a new design upper cross pin, washers, and snap rings.

Tilt the outboard to the full up position. Lock the manual tilt and engage the tilt stop bracket. With one hand on the lower unit, move the outboard up and down slightly to remove pressure on the tilt cross pin, while attempting to push the manual tilt upper cross pin out of position.

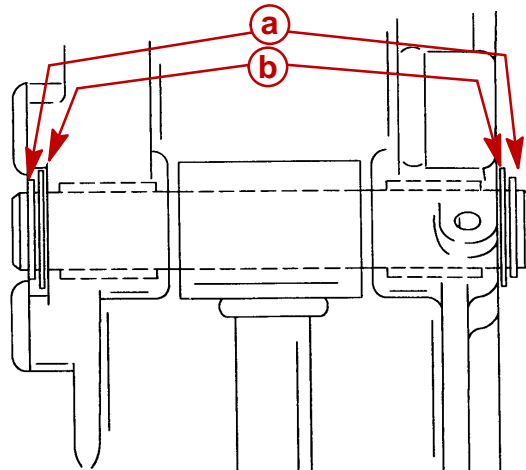
58245

- a** - Snap Ring
- b** - Washer

Swivel Bracket Pin Assembly 17-878592A1 Installed

If the manual tilt pin can be moved out of position. Remove and discard the locking tri-lobe pin and manual tilt pin. Install the Swivel Bracket Pin Assembly 17-878592A1.
