No. 2000-16

Official Notification Federal Boat Safety Act Shift Link 3.0 Litre

1999/2000 Model Year 225/250 HP, EFI 200/225 HP, Optimax 3.0 Litre Carb/Work versions S/N 0G927950 thru 0T264046

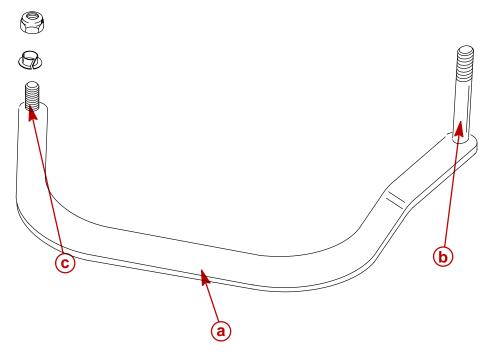
Some shift links may have insufficient weld penetration between the bracket and shift cable attaching stud. This could result in possible attaching stud breakage and loss of shift control.

- a Shift Link Bracket
- **b** Control Cable Attaching Stud
- c Shift Link to Upper Shift Shaft Attaching Stud

A letter will be sent to every registered owner of an affected outboard. The letter will advise the owner to return their outboard to their selling dealer or any Mercury/Mariner authorized dealer for the replacement of the shift link. A copy of the letter and warranty claim is included with this Service Information Bulletin.

Affected outboards in dealer inventory **MUST** have the shift link replaced when being installed/rigged on boats, (See parts required).

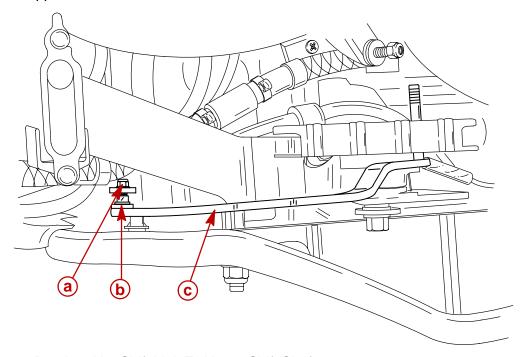
NOTE: The view below is shown with the front retainer nut loose and spacer NOT engaged into the upper shift shaft.

- a Retainer Nut Shift Link To Upper Shift Shaft
- **b** Spacer
- c Shift Link Assemble
- Install shift link into upper shift shaft, taking care that plastic bushing enters the shift shaft correctly. Install the nylock nut and drive tight.
- Reinstall shift slide, shift cable, washer, and nylock nut.
- Reinstall the port side bottom cowl, and harness clamp retainer.

After the shift link has been replaced, put a WHITE paint dot on top of the shift link bracket.
