Official Recall Notification U.S. Federal Boat Safety Act - 25/30 HP EFI FourStroke Motor Mount Retaining Nuts

Models Covered	Serial Number
25/30 HP EFI FourStroke	0R106999 - 0R201181

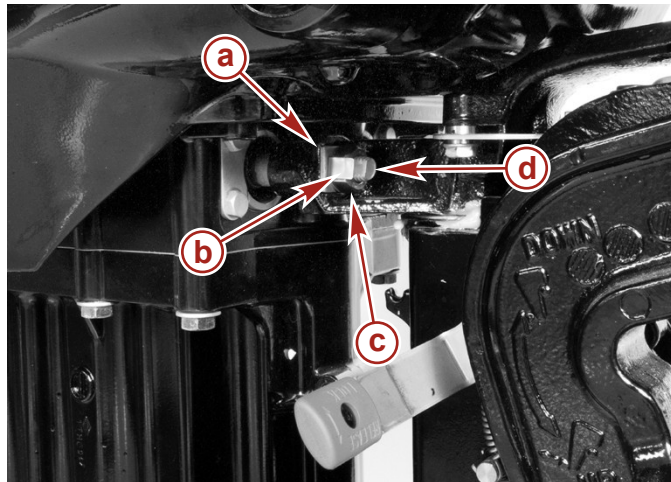
18793

Mercury Marine has received isolated complaints of the upper motor mount retaining nuts on outboards listed above coming loose due to improper torque. Mercury Marine has determined that the torque applied to these fasteners during production was not sufficient to retain the proper torque under all operating conditions.

1. Bend the tab of the locking plate away from the upper motor mount retaining nut.
