Official Recall Notification U.S. Federal Boat Safety Act - DTS Command Module Lever Fault

Models Covered
Mercury/Mariner with Digital Throttle and Shift (DTS)

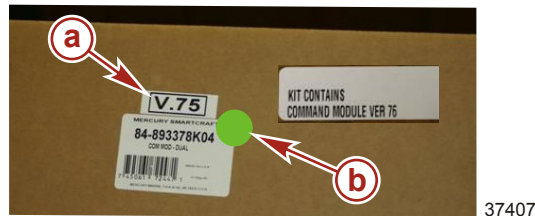
Command Module Boxes within Master Kits

a - Label is placed directly over the top of existing version label here

b - Green dot

Kits with version 75 command modules will show "V.75" on the label.

Kits with the command modules will have a sticker over the top of the old V.75 label saying "Kit Contains Command Module Ver 76."

A green dot will be placed next to the box part number label.

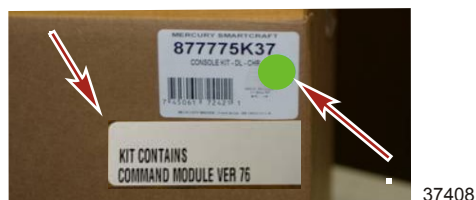
Master Kits Labeling

A label saying "Kit Contains Command Module Ver 76" will be placed just below the master box part number label, as shown.

A green dot will be on the master kit part number label in the position shown.
