# Service Bulletin

Bulletin No. 2009-08  
OEM No. 2009-07

## Wire Chafing 2.5 Liter OptiMax

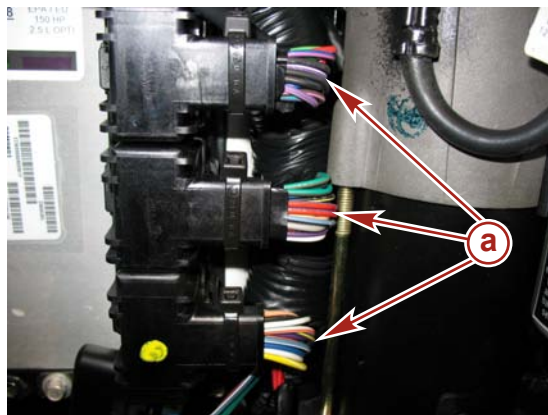
41012

The 2.5 Liter OptiMax engines in the above serial number range may have an incorrectly routed wire harness. This could result in unprotected wires rubbing against the starter motor, causing the wires to chafe/fray and, subsequently, short out. A short can result in potential loss of various engine functions, depending on which wire is shorted.

**a** - PCM wire bundles – center bundle contacting starter motor

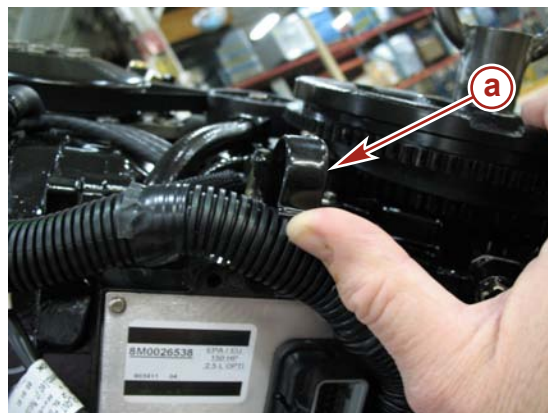
41013

**a** - J-clip above PCM

1. Remove the three PCM harness connectors from the PCM and remove the harness from the J-clip above the PCM.

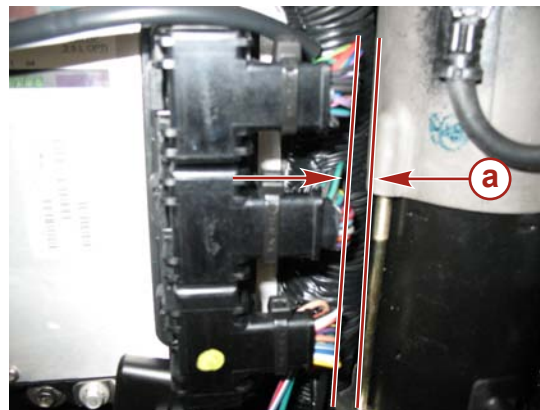
41017

**a** - 6.35 mm (1/4 in.) clearance between wire bundles and starter

- Position the harness back into the J-clip and roll the J-clip down around the harness to hold it securely and still allow for cowl clearance.

**NOTE:** Using a 6.35 mm (1/4 in.) thick plastic or wood spacer to check for clearance of the wire bundles may be helpful. When the spacer is inserted between the wires and the starter, the spacer should not push on the wires to fit the opening.
