1.5L OptiMax Compressor Temperature Sensor Torque Change Models Affected

Models Covered
Mercury/Mariner All 75–125 HP 1.5L OptiMax Engines

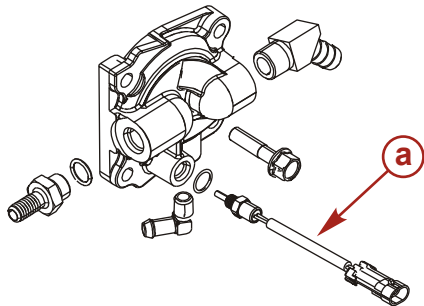
a - Temperature sensor

To prevent under cowl water leakage, the temperature sensor mounted on the air compressor cylinder head has a new torque. See the torque specifications following. Please use this new torque value when servicing the 1.5L OptiMax compressor. This information will be included in the next revision of the service manual.

Description	Nm	lb-in.	lb-ft
Temperature sensor	13.6–20.3		10–15

This change was implemented with starting S/N 1B775632.
