Joystick Piloting for Outboard Command Control Module (CCM) and Thrust Vector Module (TVM) Calibration Update and Joystick Inspection

Revised July 2018. This bulletin supersedes the previous bulletin number 2016-12R3 September 2017.

Models Covered	Serial Number Or Year
All Joystick Piloting for Outboard models that use Design 2 joysticks	-

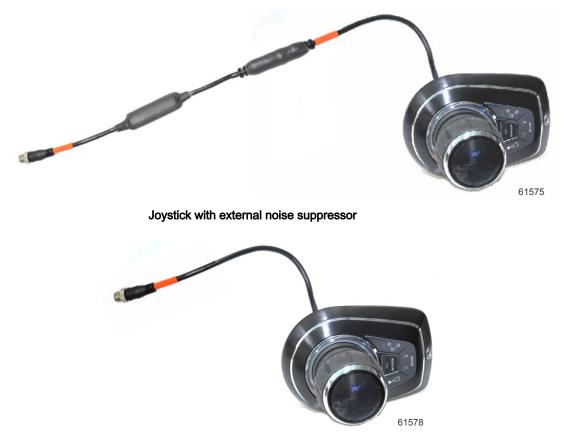
If the joystick is equipped with the external noise suppressor, replace the joystick assembly. The following two images show the visual differences between the two designs.

This joystick inspection should be performed at the next customer service interval.
