Service Bulletin

Bulletin No. 2012-09
OEM No. 2012-05

Alternator End Cover Contacting Cylinder Block—150 FourStroke Models Affected

Models Covered	Serial Number
150 FourStroke	1B906474–1B943665

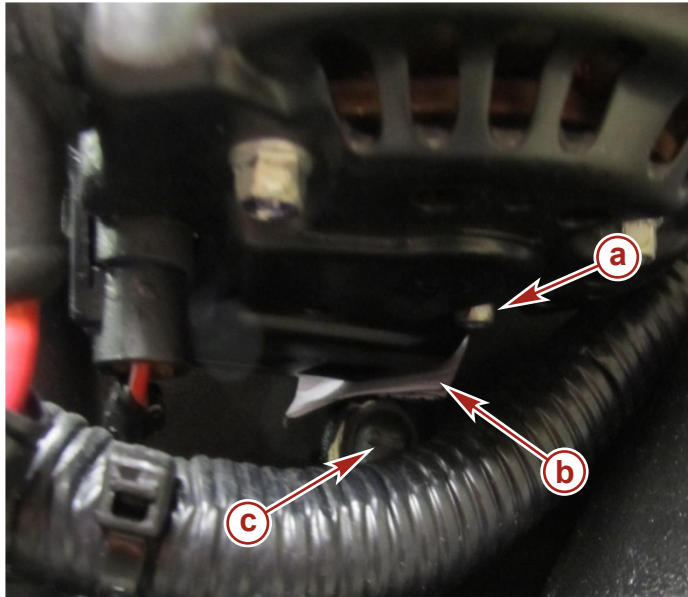
51272

- Inspect for a 0.254 mm (0.010 in.) clearance between the innermost corner of the alternator end cover and the cylinder block just above the flush hose fitting boss.
IMPORTANT: Use a folded sheet of paper or a piece of cardboard stock which is flexible enough to bend around the flush fitting boss. A sheet of copy paper is approximately 0.1 mm (0.004 in.) so three thicknesses or a trifold piece would work as a gauge.

- a - Alternator end cover
- b - Gauge, folded paper or cardboard stock
- c - Flush hose fitting boss

2. If the folded paper sheet or cardboard gauge can slide between the alternator end cover and the cylinder block, the clearance is sufficient and no corrective action is required.
3. If the gauge cannot slide between the alternator end cover and the cylinder block as described, proceed to the correction instructions.

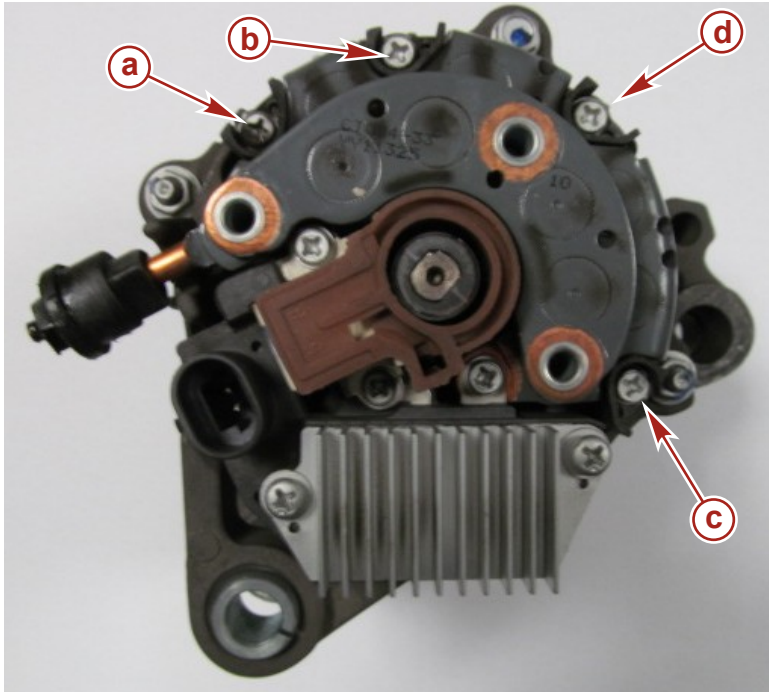
51273

Meter Test Leads		Meter Scale	Readings (Ω)
Red	Black		
Terminal A	Terminal D	Auto	1.0 ohms or less
Terminal B	Terminal D	Auto	1.0 ohms or less
Terminal C	Terminal D	Auto	1.0 ohms or less

- a** - Terminal A winding
- b** - Terminal B winding
- c** - Terminal C winding
- d** - Terminal D winding (common)

1. Remove and retain three screws securing end cover.
IMPORTANT: To avoid damaging the B+ terminal stud, use hand tools only to loosen the B+ terminal hex nut.
2. Loosen the nut on the B+ terminal to allow the insulator collar to be disengaged from the alternator end cover.
3. Remove the alternator end cover.
4. Using an ohmmeter verify that the alternator phase windings have the specified continuity.
5. Replace alternators which do not pass all of the continuity tests.

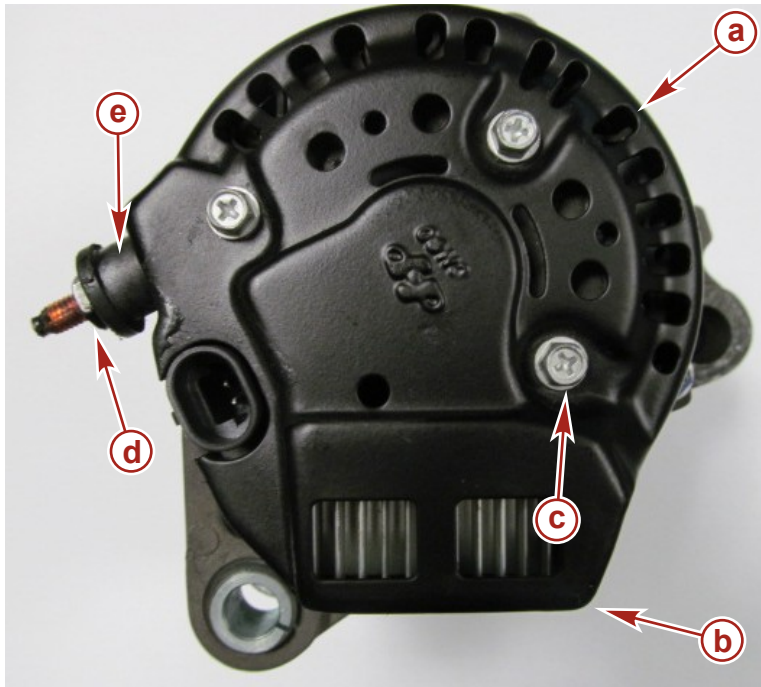
51274

- a - Alternator end cover
- b - Area of contact with cylinder block
- c - Screw (M4 x 25 mm)
- d - Hex nut (M6)
- e - Insulator collar

6. Install the new alternator end cover and secure it with the three retained screws. Tighten the retaining screws to the specified torque.
7. Engage the insulator collar into the alternator end cover and tighten the B+ hex nut to the specified torque.

Description	Nm	lb-in.	lb-ft
Alternator end cover screw (M4 x 25 mm)	4.5	40	–
B+ terminal nut (M6)	3.6	32	–

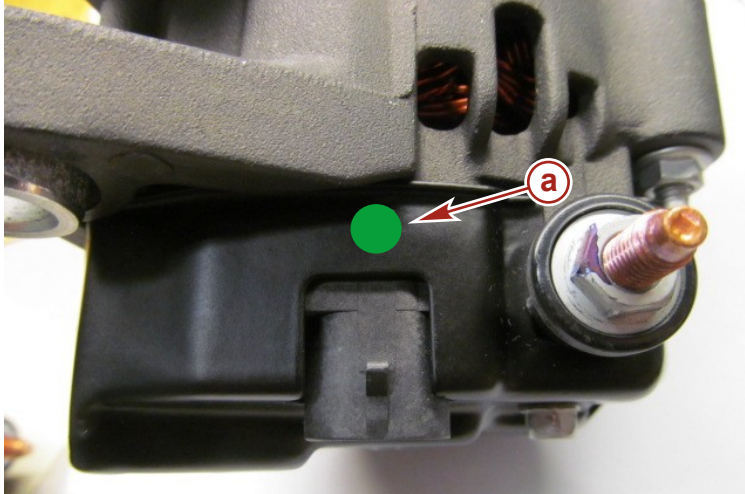
51275

Affected outboards that have been reworked at the factory are identified with a green paint mark located on the alternator end cover just above the 2-pin connector.

a - Green paint mark

Dealers should also identify any inspected or reworked alternators with a green paint mark at the same location.
