Gas Assist Thrust Washer Replacement

Models Covered	Serial Number Or Year
60 HP EFI FourStroke	1C139538–1C207842
75 SeaPro	1B828336–1B913257

NOTE: This Service Bulletin only pertains to gas assist equipped engines. No power trim and tilt equipped engines are affected.

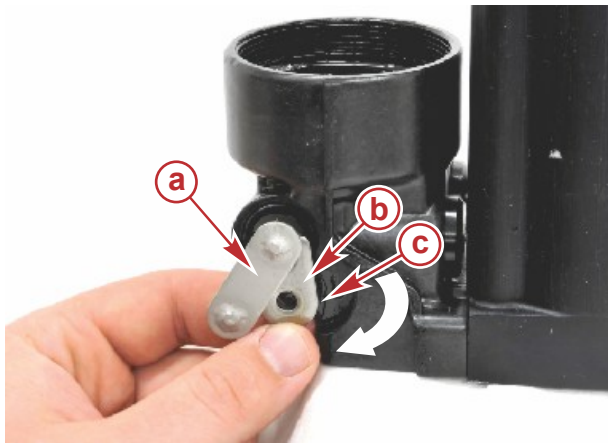
51738

- a - Gas assist camshaft
- b - Camshaft retainer plate
- c - Spacer

4. Rotate the camshaft retainer and spacer down and remove them from the camshaft.

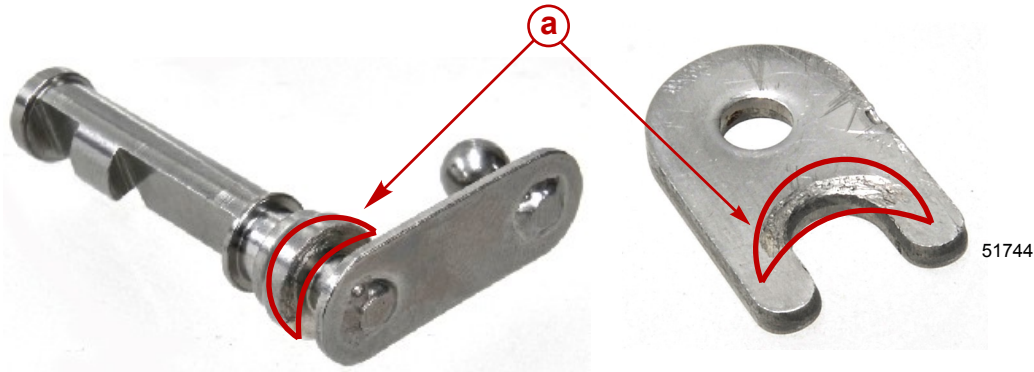
6. Inspect the camshaft and camshaft retainer plate for signs of damage. If damage is present, replace the camshaft assembly. If no damage is found, proceed with thrust washer and spacer replacement. (Camshaft removed from manifold for clarity purpose only. Do not remove unless damage is evident).

a - Damage to the camshaft and camshaft retainer plate

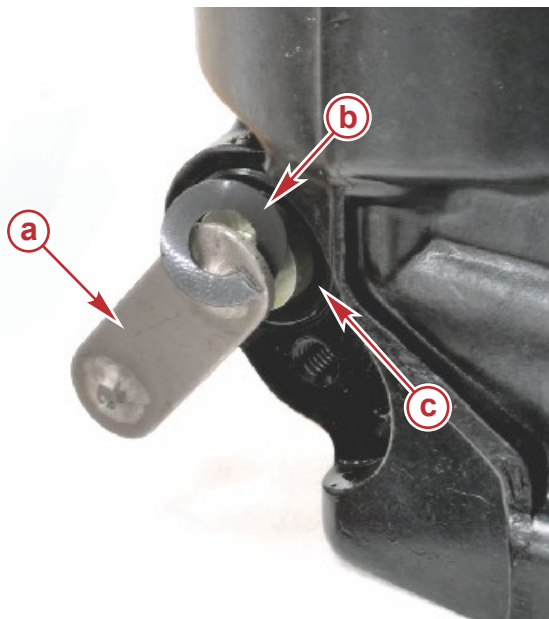
- a -** Gas assist camshaft
- b -** Thrust washer
- c -** Gas assist camshaft shoulder (area 2-4-C with PTFE needs to be applied to)

7. Install the replacement thrust washer on the camshaft. Using the slit in the thrust washer, spin the thrust washer onto the gas assist camshaft. Once the thrust washer is installed, apply 2-4-C with PTFE to the shoulder of the gas assist camshaft.

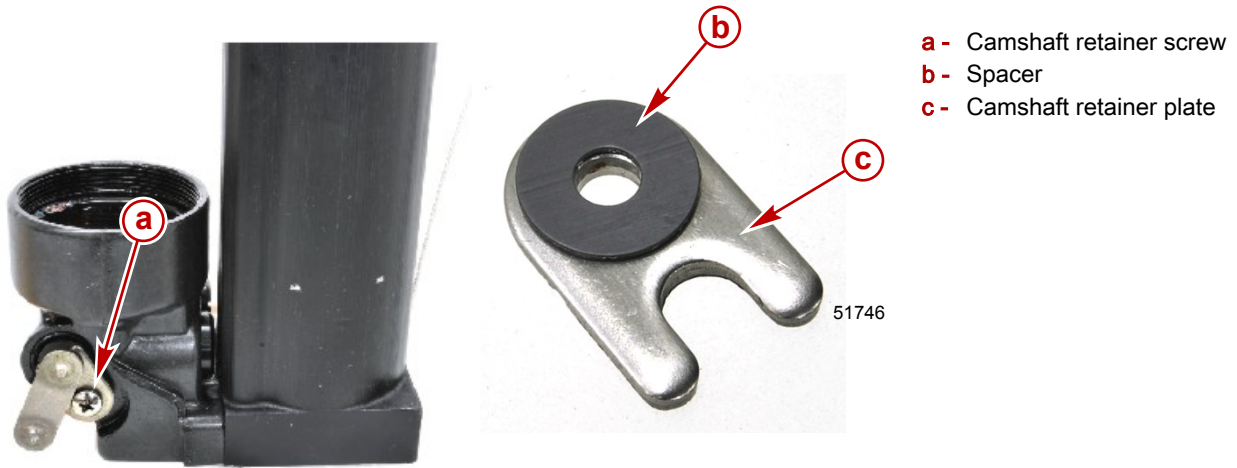
- a - Camshaft retainer screw
- b - Spacer
- c - Camshaft retainer plate

8. Install the camshaft retainer plate and spacer. Torque the screw to specification.

Description	Nm	lb-in.	lb-ft
Retainer plate screw	3.6	32	-
