SmartCraft Clean Power Harness

USA customers: Return any parts in your inventory using the Mercury Precision Parts Under 30 Days Returns Program. You may use the form on the back of any parts and accessories packing list. Please note on the form that the return is part of Outboard Service Bulletin 2013-10 or Outboard OEM Bulletin 2013-07.

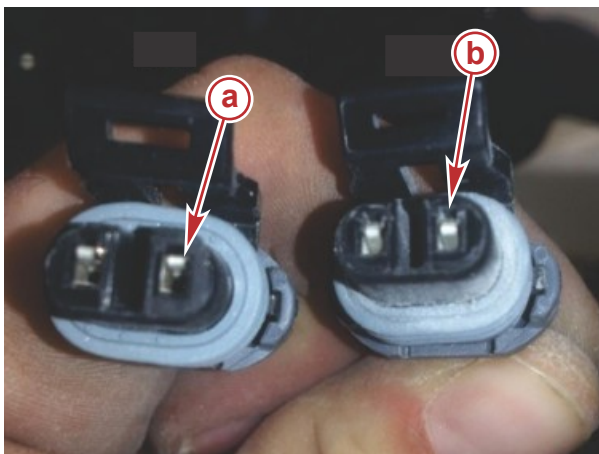
53621

During the manufacturing process some of the female terminals in the clean power 2-pin connector were spread too wide, creating the possibility for either an intermittent electrical failure (occasional engine shutdown), or a complete break in power (engine cannot start, or started then stopped and cannot be restarted). For connectors that were not spread too wide during the manufacturing process, normal electrical component performance and reliability is expected. For connectors that were spread too wide there is a high probability that one of the two electrical failures (intermittent or complete open circuit) will occur either immediately on attempted engine start-up, or very soon thereafter.

a - Bad
b - Good

Correct if any of the conditions described in the **Situation** section are reported by the customer, or observed during setup, inspect the battery connections and replace any clean power harness in the date codes listed if the conditions mentioned in this bulletin are present. Replace with P/N 888416T04.

NOTE: Do not attempt to repair the harness. Replace clean power harness complete.
