Service Bulletin

Bulletin No. 2017-17

Power Tilt Wire Harness—15/20 HP FourStroke

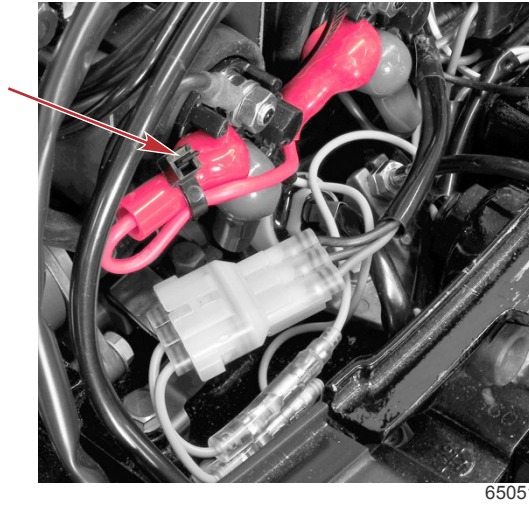
Outboards that have been reworked at the factory, or by a dealer, will have the 12-volt power supply red shunt wire secured with a cable tie. Refer to the following illustration.

Corrected shunt wire secured with cable tie

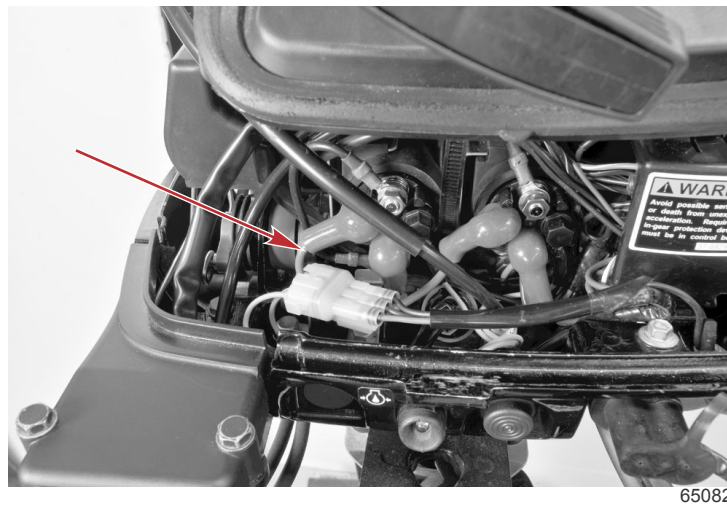
1. Locate the red shunt wire that is connected between the up and down solenoid.

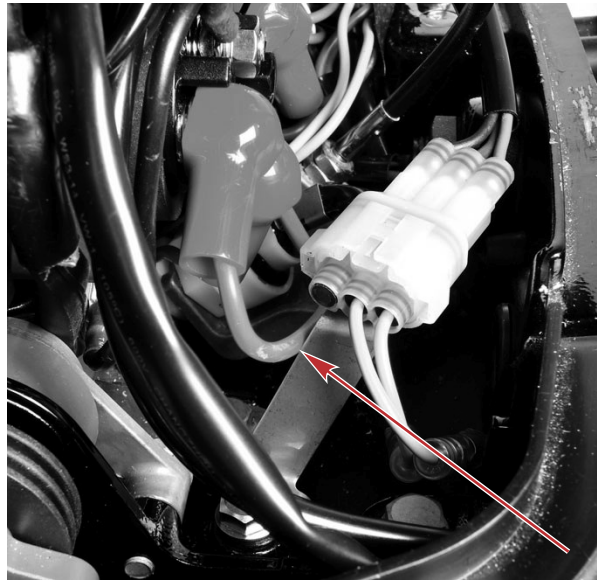
65085

2. Inspect if the red shunt wire has made contact with the metal bracket.

3. If the insulation has been abraded through and the wire core has made contact with the metal bracket, the insulation will be melted. If you encounter a red shunt wire with melted insulation, you must inspect all wire harnesses for damage. If there is damage beyond the red shunt wire, contact Mercury Marine Technical Service or your regional service center.

4. Remove and replace the red shunt wire regardless of its visual condition.
 - a. Remove the insulator boots from the red shunt wire.
 - b. Push the new wire through the power wire insulator boot on both ends of the wire.
 - c. Secure the wires to the solenoids.

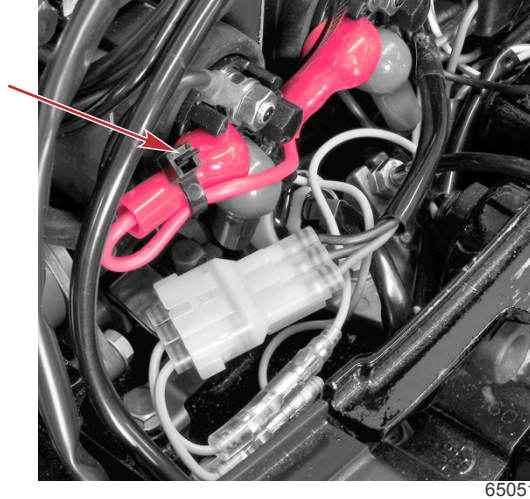
Shunt wire secured with cable tie

- d. Route the red shunt wire over the down solenoid red insulator boot and secure the shunt wire with a cable tie. Refer to the following illustration.
