MERCUISER SERVICE BULLETIN

Number: 66-2A 66-

Date : 3/1/66 03

A. POWER TILT HYDRAULIC HOSE INSTALLATION - MERCRC. IA-IB-IC [Reprinted Bulletin]

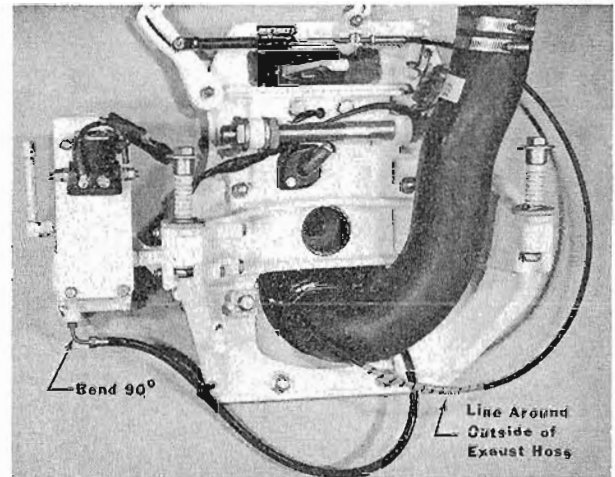
To eliminate possibility of engine coupling damaging hydraulic pump hose, the hose is routed around outside of exhaust hose. (Figure 1)

Hydraulic pump hose, which may be damaged when installed other than as shown, right, cannot be covered under the factory warranty policy.

On new installations, or when replacing hydraulic hose, it is important that hose be installed as shown in figure on right.
