MERC[RUISER SERVICE BULLETIN

Section: XII (Bulletins)
Number: 67-866-20
Date : 11/23/66 x

- A. Tightening Bellows Clamps - All MerCr. Drive Units (Sec. II)
- B. Remedy When Drive Unit Unlocks in Reverse - MerCr. 120-160 (Sec. II)
- C. Engine Crankcase Oil Capacity - MerCruiser 80 (Owners Guide)
- D. Snap Ring Pliers - All Stern Drive Units (Section XI)
- E. Heavy Duty Water Pump Kit - MerCruiser "O" Drive (Sec. IX)
- F. Repair Kits - MerCr. 60 Hydr. Shift Sender & Receiver (Sec. X)

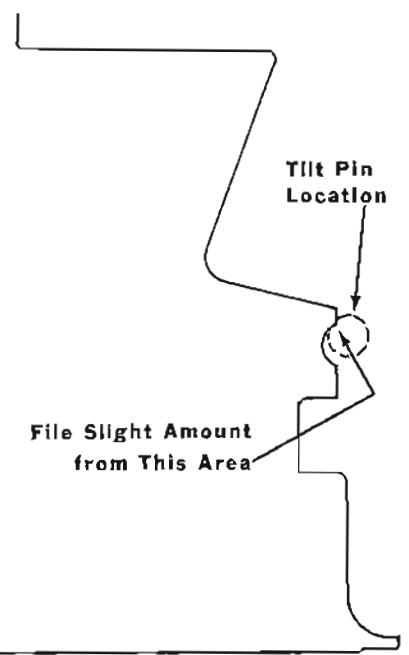
Occasionally, a MerCruiser 120 or 160 Stern Drive Unit (standard or Power Tilt) will tilt up when shifted into reverse gear. (Power Trim has a hydraulic lock.) This may occur when the drive shaft housing tilt pin recesses on the drive shaft housing do not align with the tilt pin and, thus, does not allow the drive unit to travel down far enough on the tilt pin.

Figure 1. Area to Be Filed ▶

If this condition is experienced, it will be necessary to file a slight amount of metal from the top end of the tilt pin stop area, as shown in Figure 1. It may be necessary to file from either one or both sides.

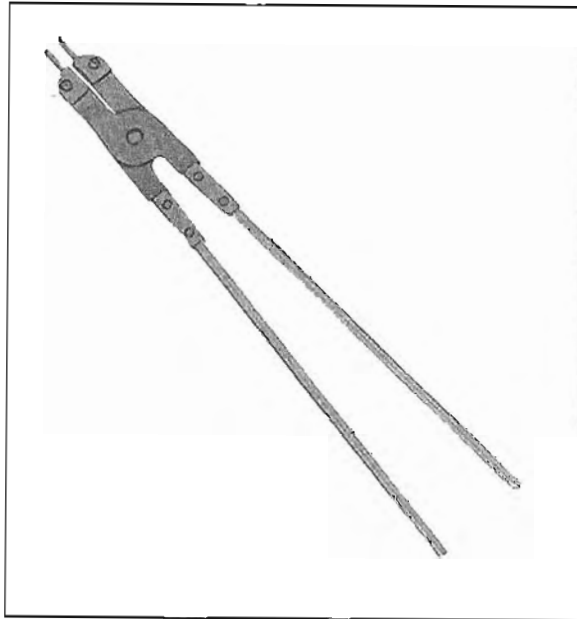
A new, heavy-duty Snap Ring Pliers (C-91-37240A1) now is available with extra long handle (Figure 2) This tool has been designed to remove and install the gimbal housing ball bearing snap ring on MerCruiser Stern Drive Units. (Figure 3)

Figure 2. Snap Ring Pliers (C-91-37240A1)

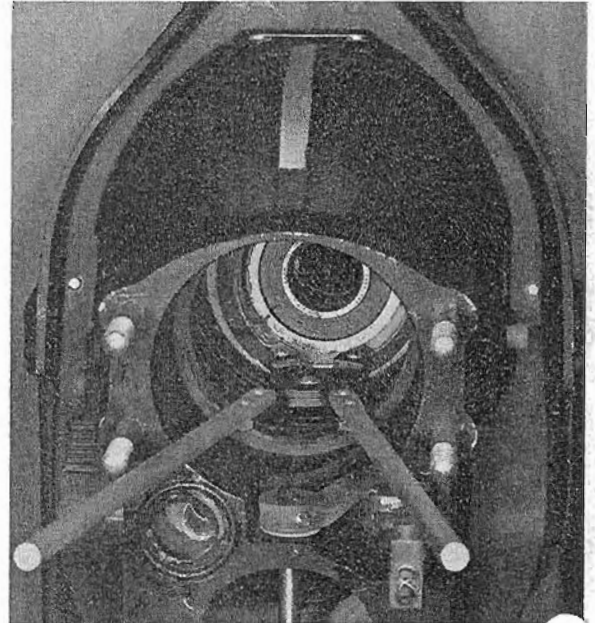
Figure 3. Employing Snap Ring Pliers (C-91-37240A1)
