Section: XIII (Service Number: Bectins

Date : 10/11/62

- A Sealing Procedure, Drive Shaft Housing to Bell Housing, MerCruiser I
- B. Galvanic Corrosion Induced by Anti-Fouling Copper-Base Bottom Paint
- C. Starter Solenoid (25661) Inspection
- D. Ignition Coil Test

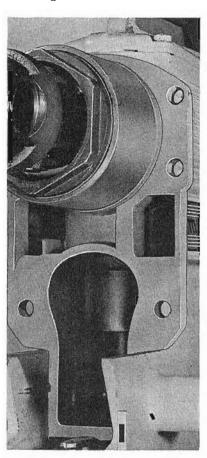
The type of sealing between the MerCruiser I drive shaft housing and bell housing has been changed. Original production depended upon two (2) gaskets (Figure 2 for sealing the 2 housings. (Figures 1 and 2) This now has been changed to provide sealing primarily on 2 rubber sealing rings (Figures 3 and 4) in addition to a single gasket. (Figure 4)

The earlier drive shaft bousing (Figure 1) can be used only with earlier bell bousing (32499A1) and 2 gaskets (27-32599), shown in Figure 2, or with replacement bell housing assembly (34140A1) used on MerCruiser I, Serial No. 1535211 and below.

Use Gasket Adhesive (92-25234) to secure gaskets to bell housing. Always replace used gaskets to assure a good seal to prevent water leakage.

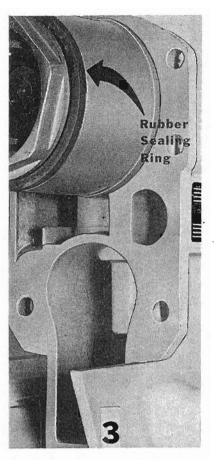
This new style drive shaft housing (Figure 3) can be used with either the earlier bell housing (Figure 2) or the new bell housing (Figure 4), providing the correct gaskets are used. Gaskets for the earlier bell housing (2 gaskets 27-32599) are shown in Figure 2, for the new bell housing (one gasket 27-33796) in Figure 4.

When new style bell bousings 33506A1 or 33795A3 (Figure 4) are used, be sure to use new style gasket 27-33507 or 27-33796 used on MerCruiser I, Serial No. 1535212 and up.
