MERCUISER SERVICE BULLETIN

Section: XII (Service
Bulletins)
Number: #63-07
Date : 7/3/63

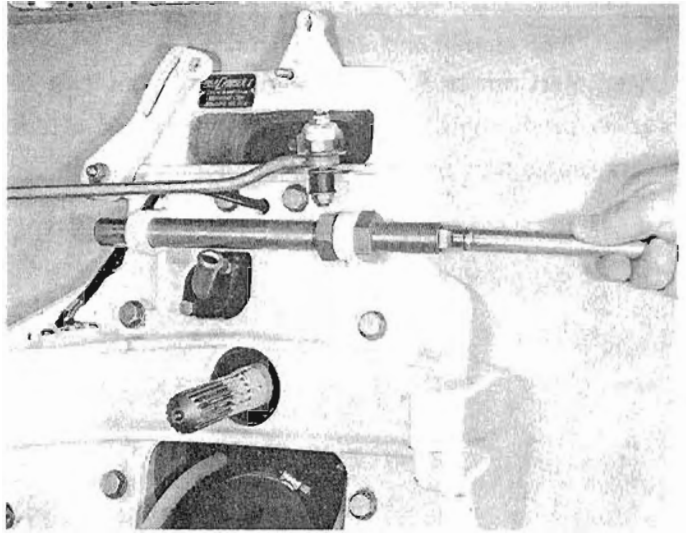
Figure 4. Straightening Cable

If the new MerCruiser Ride-Guide cable (34451A) cannot be inserted into the Ride-Guide steering tube on the drive units, the cable end may be slightly bent. (Figure 4) This condition can be corrected easily by inserting the end of the stainless steel cable into the end of the Ride-Guide tube and bending the end straight. There is not enough force here to cause any damage to the cable tube.

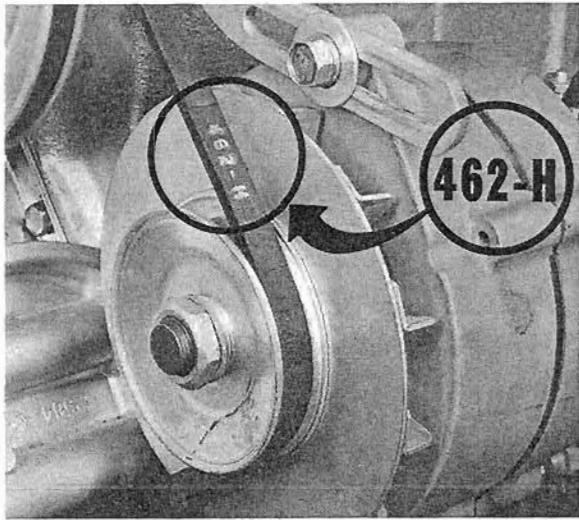
Figure 5. New 32850 Alternator Belt

Later MerCruiser I "110" and "140" engines use a $\frac{1}{4}$ " shorter alternator belt (32850) than earlier production. If it is difficult to tighten alternator belt sufficiently, install one of the newer belts, same part number. Look for identification No. 462-H marked on new belt. (Figure 5)

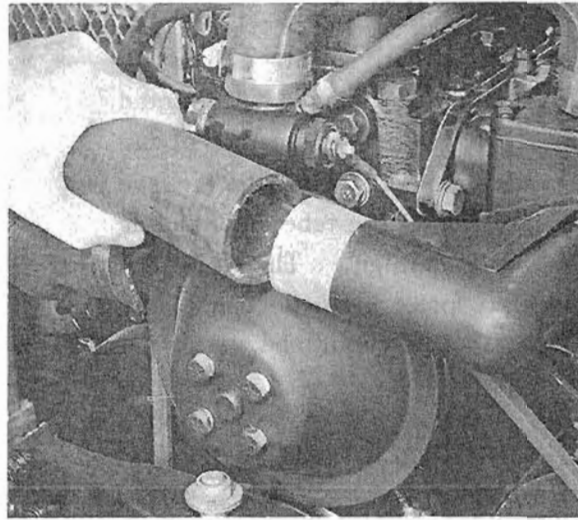
Figure 6. Sanded Area

It has been found that the black paint which is used on later MerCruiser marine engines is very slippery and tends to allow water hoses to slip off the engine, unless hose clamps are very tight. Production now leaves the metal surface unpainted wherever a hose is slipped on. It is recommended that, if a hose slips off or is removed for other reasons, the black paint be sanded off where the hose covers (Figure 6), that the inside of the hose be roughened slightly with sand paper and that the hose be reinstalled with the hose clamps tightened snugly to 25 in. lbs. At the same time, install a new style Water Pressure Regulating Valve Assembly (24-35087A1) on the relief valve body assembly. (Figure 7)
