# MERCUISER SERVICE BULLETIN

Section: 2 (Installation)

Number: X 64-13

Date : 7/30/64

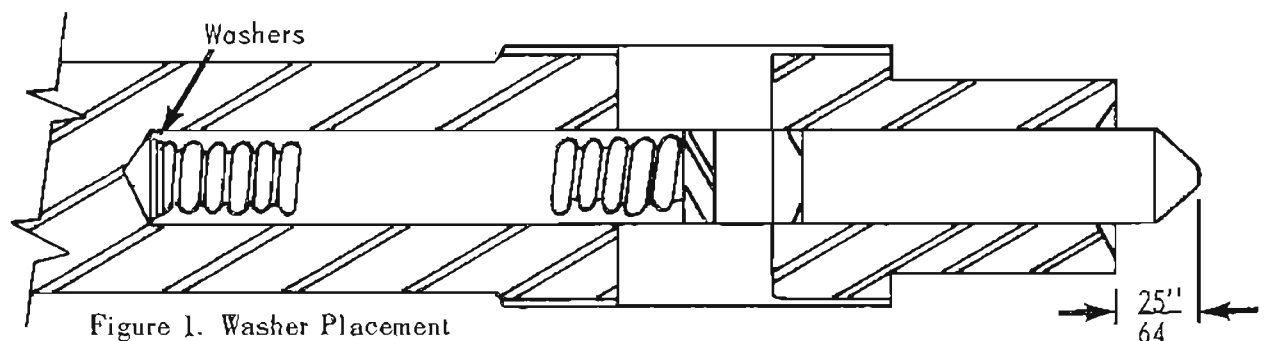
A new shift cam follower spring assembly (B-24-37610A1) has been incorporated in MerCruiser IA-IB-IC Stern Drive Units. It also is adaptable to earlier MerCruiser I Stern Drive Units. Purpose of the new spring assembly is to reduce the shifting effort.

1. Remove propeller shaft from gear housing, as outlined on P. 1 of Section 9.
2. Remove cross pin retaining spring from sliding clutch and remove cross pin from clutch.
3. Remove cam follower, cross pin slide and cam follower spring from propeller shaft.
4. Hold propeller shaft in vertical position with splined end of shaft down.
5. Place 3 washers, new spring, cross pin slide and follower inside propeller shaft.
6. Measure distance from tip of cam follower to end of propeller shaft. Distance must be  $25\frac{1}{64}$ " , plus-or-minus  $1\frac{1}{64}$ ". If measurement taken is not within tolerance, add or subtract washers under follower spring as required. Each washer is  $1\frac{1}{32}$ " thick. (Figure 1)

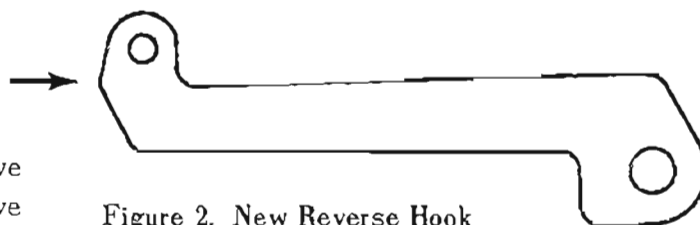
Figure 2. New Reverse Hook

Occasionally, a MerCruiser I or IA-IB-IC Stern Drive Unit will tilt up when shifted into reverse gear. This usually is caused by a slightly worn reverse hook arm stop assembly (B-32588A1) which prevents the hooks from locking.

A change has been made on the reverse hook (B-32520), a revision on the spring end to make a sharp corner. This improves the consistency of the hook to lock in reverse, particularly after many shifting cycles.

If the reverse hook arm stop assembly is not worn, the installation of the reverse hook alone will correct this condition. If the reverse hook arm stop assembly is worn, it also will necessitate replacement of that part. See Figure 2 for drawing of new reverse hook.
